HISTORICAL ARCHITECTURAL SURVEY, PARRS CLOSE, 19 CHURCH STREET, BINGHAM

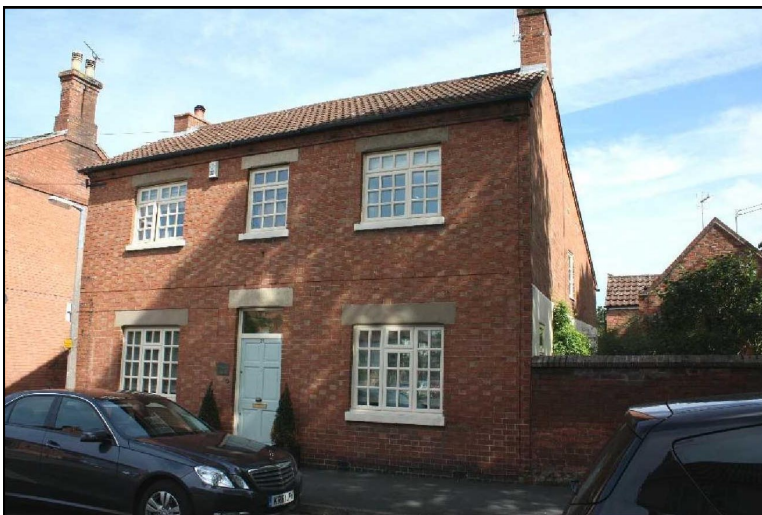
There is some variation in the brickwork. The south frontage has bricks accurately laid in Flemish

bond to a chequerboard effect with lighter toned headers (above, left), the bricks being 2¾ inches (70mm) thick and up to 9¾ins. (248mm) long. Similar

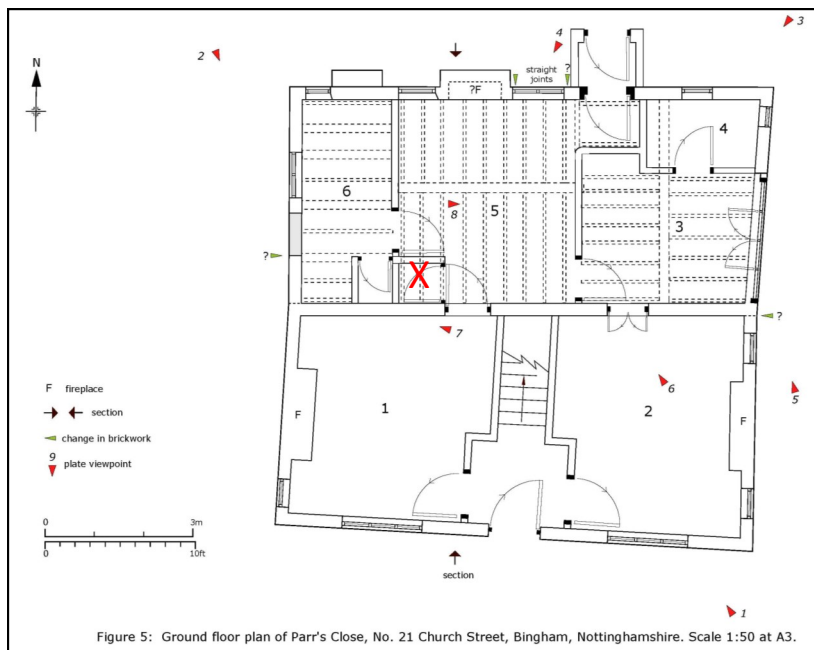
Excluding the entrance hall, the lower floor has six rooms of varying size. These are divided between two formal rooms in the south-facing front range and four in the less formal back range, that include two kitchens and a utility room. The irregular alignment of the south frontage wall in relation to the central party wall shows in the layout of the flooring in Rooms 1 and 2 (see survey pole indicator in photo, right).

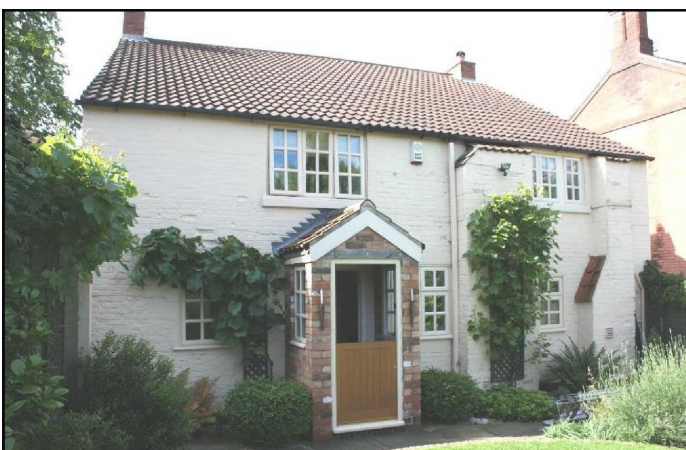
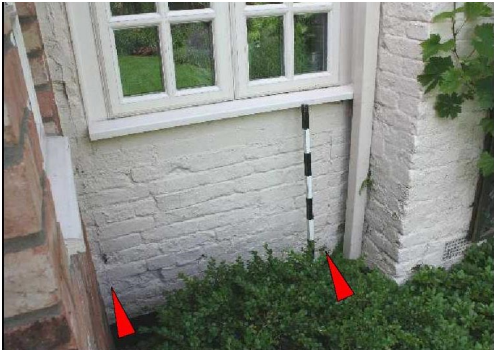
The ground floor rooms to the rear have lower ceilings which are crossed by timber beams and joists, the pattern of which reflects a division of the range into three cells by half-brick thick dividing walls. That between Rooms 3 and 5 appears to have been largely rebuilt to accommodate a rear entrance (with an added

porch, which is later than the doorway, right) that has replaced a more centrally-spaced doorway, now partly blocked up and with a window (the position is shown by the arrowed straight joints, left). The central room was heated by a fireplace stack that projected from the north wall; this is no longer evident on the inner side, being hidden by kitchen units. The narrow west room, now a kitchen / utility room, has a smaller added stack at its north end,

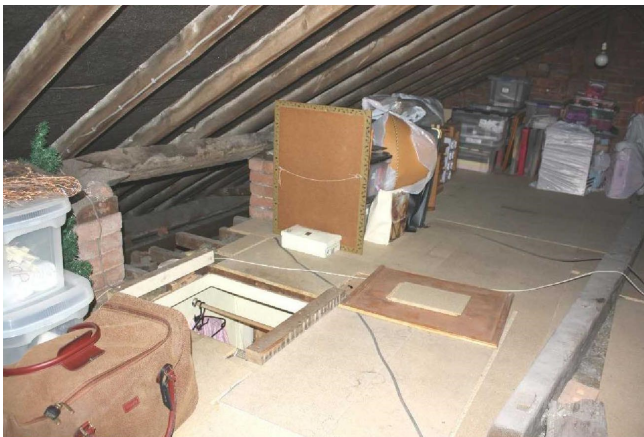
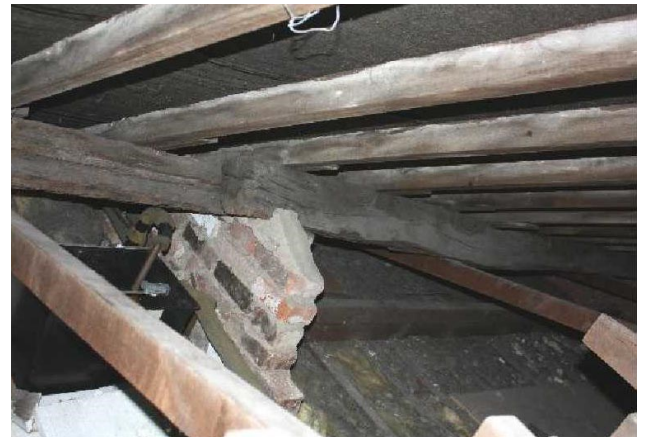
The roof space is principally over the south range with a catslide roof running down over the lower north range; the limited pitched space here is inaccessible. The roof consists of rafters and a single line of purlins on either side, supported on small brick pillars and dwarf walls on the south side which are on the same lines as walls at lower levels (left and right, below).

The roof has clearly been altered and part of the evidence are two redundant long beams with mortices showing that now run along the centre of the attic floor (arrowed, right).
