**CB01, CB01A and CB01E**

**ARCHAEOLOGICAL REPORT ON**

**BEAUVALE HOUSE  
18, MARKET PLACE**

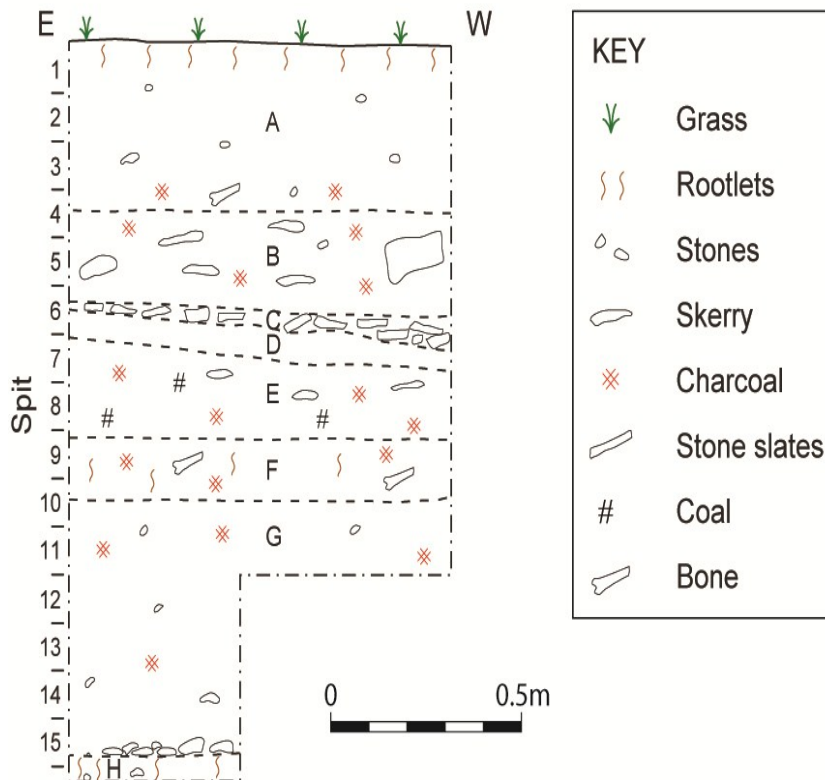
#### Test pit CB01

- A *Topsoil of very dark brown-black sandy loam, skerry and sandstone 1%. Small pebbles, roots and rootlets, bone and charcoal near bottom.*
- B *Very dark brown-black sandy loam topsoil with plenty of skerry and a large sandstone cobbles, charcoal.*
- C *Demolition layer of stone, slates, some with holes in them.*
- D *Red-brown clay mixed with subsoil*
- E *Brown-grey clayey sand with abundant charcoal and coal, tabular skerry.*
- F *Made ground of red-brown clay with charcoal, carbonised rootlets and bone.*
- G *Grey-brown clayey sand with charcoal, sparse stones*
- H *Red-brown sandy clay with soil, root tubes, some pebbles. Irregular top, patchy gravel on surface*

The upper unit of dark, organic soil is 30-35 cm thick and contains a few stones and bones. In comparison with the pits dug next door it is probably modern and relates to the landscaping that took place when Beauvale House was modernised in the mid 19th C. Unlike CB34 and CB35 there is no distinct upper layer that can be related to the modernisation of the two buildings that took place in the mid 20th C. The topsoil here, therefore, equates to the made ground context in CB34 and CB35.

Below this, a similar organic soil is the original, 19th C soil, which contains the building material of skerry, sandstone pieces, and roofing slate with charcoal, bone and pot fragments.

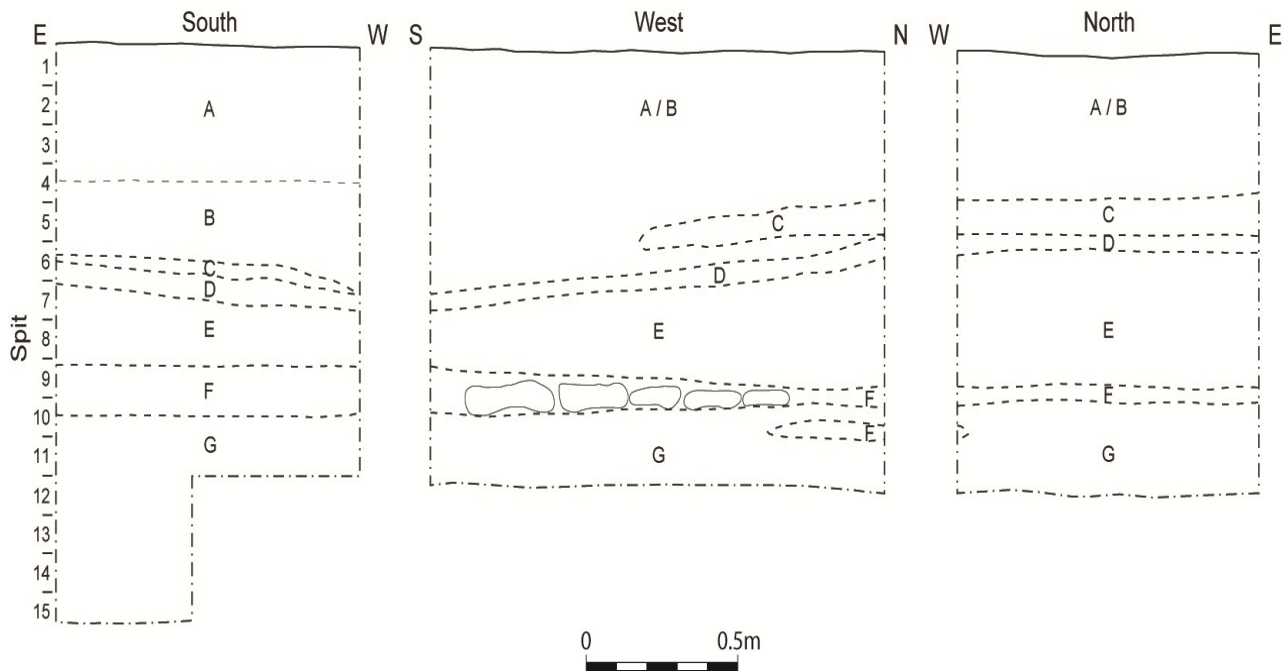
*Diagrammatic section of the three of the walls in CB01. the context descriptions are the same as in the diagram overleaf.*

stones are set on edge between the larger ones to strengthen it and in CB01E a large part of the feature consists of small stones packed tightly together on edge. The largest stones in the feature measure 30 x 30 cm square; others 40 x 12 cm and 34 x 25 cm. The large pieces are all skerry, some showing ripple marks. There are some medium-grained sandstone pieces in CB01 and siltstone. In CB01E there are additional stones, among which are polished, rounded Triassic cobbles 7–10 cm of coarse pebbly sandstone, quartzite breccia (a rock made up of angular, broken bits of

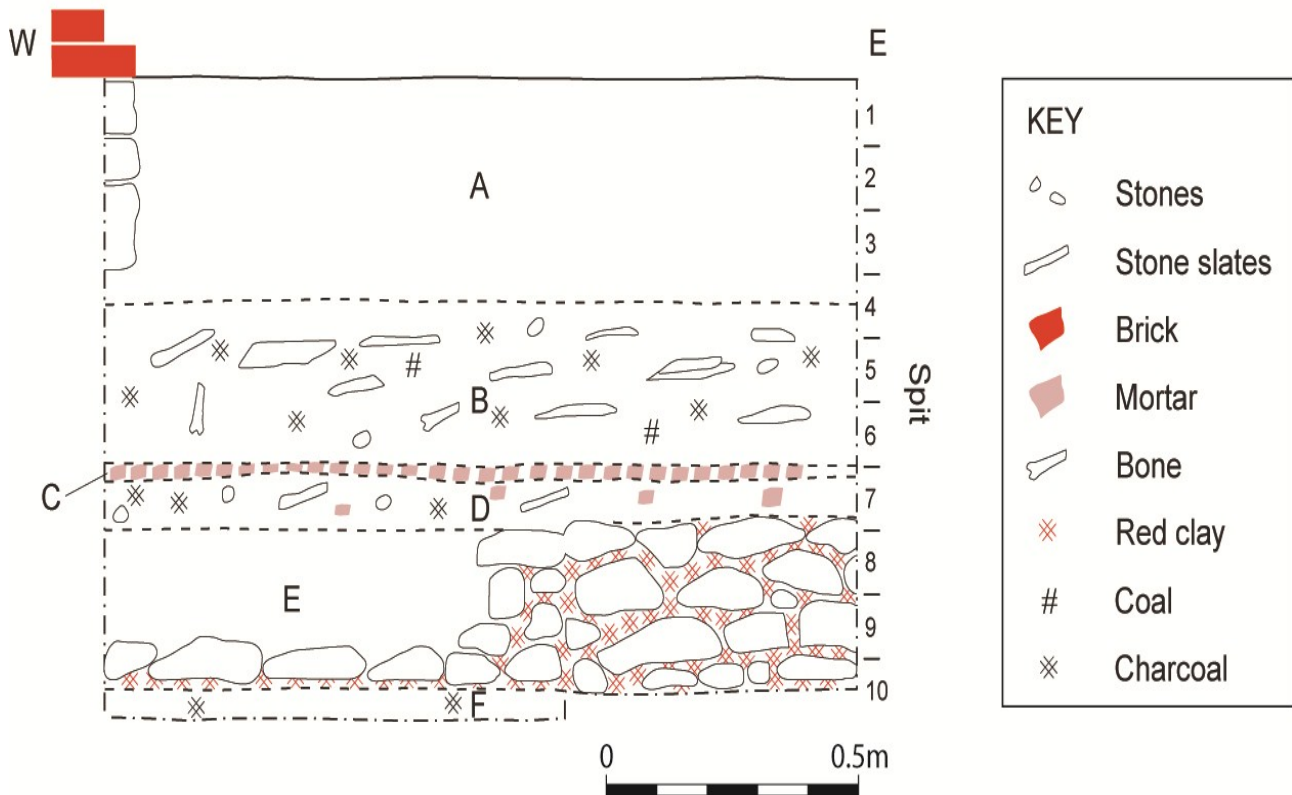
*Diagrammatic section of the south wall of pit CB01E. Key same as for CB01*

rock) and fine quartz sandstone. A dark green volcanic rock called andesite is probably Charnian in age from Charnwood Forest. These are likely to be cobbles collected from the Trent. One rectangular stone, 21 x 13 x 7 cm is thinly laminated very fine quartz sandstone and appears to have been dressed.

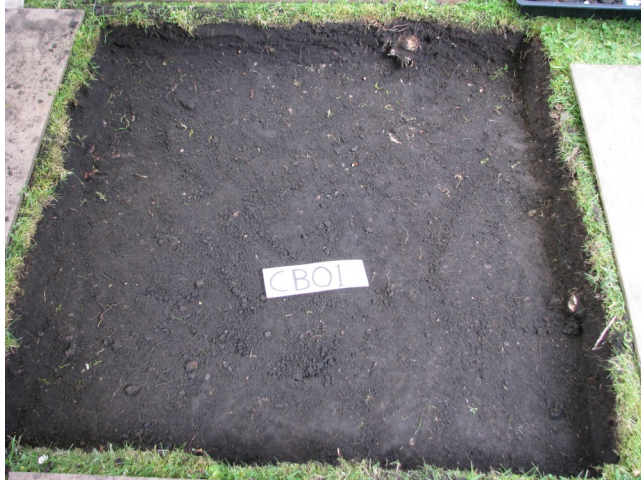
IMG\_1525 view north at 10 cm depth

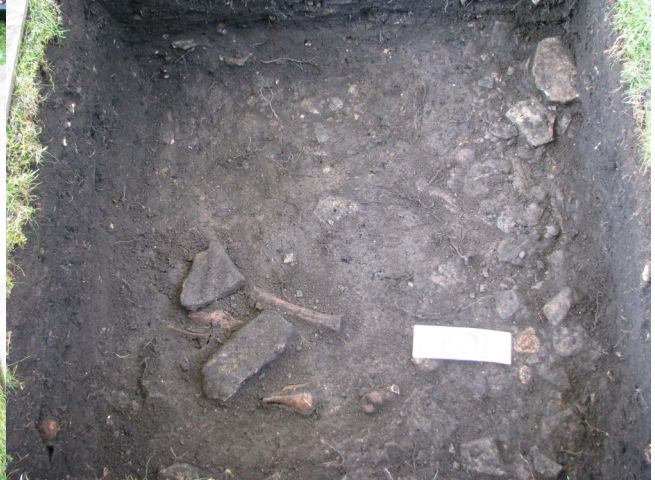
IMG\_1530 view north. Top of demolition layer at c 50 cm

The demolition layer between 50 and 60 cm depth mostly consists of limestone roofing material, some with holes in them and a few with rusted iron nails in the holes. It is assumed that the layer represents a roof collapse, but it is difficult to put a date to it. Medieval pottery is present in the layers above it. The most abundant and the most significant is Midland Purple Ware, which dates from the 15th C and occurs only above the demolition layer.

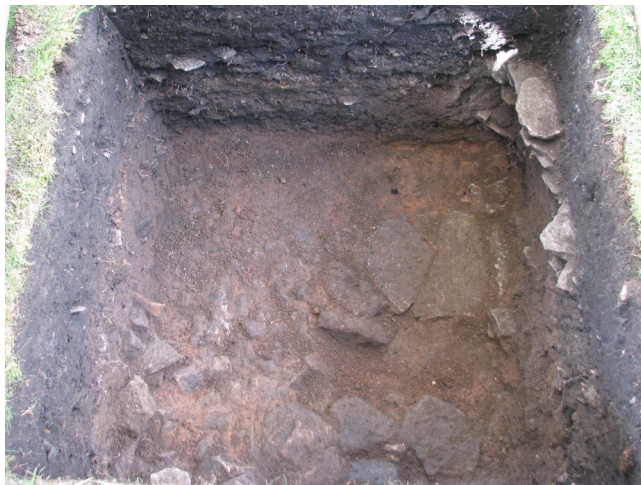
IMG\_1536 view north. First view of the stone-work layer at c 80 cm.

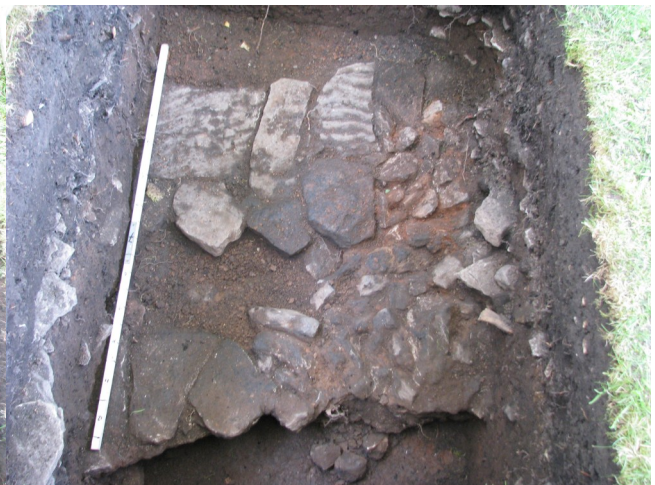
IMG\_1545 c 80 cm, view south. Stonework showing ripple marks in some skerry slabs. N side of wall excavated; south side shows clay abutting wall.

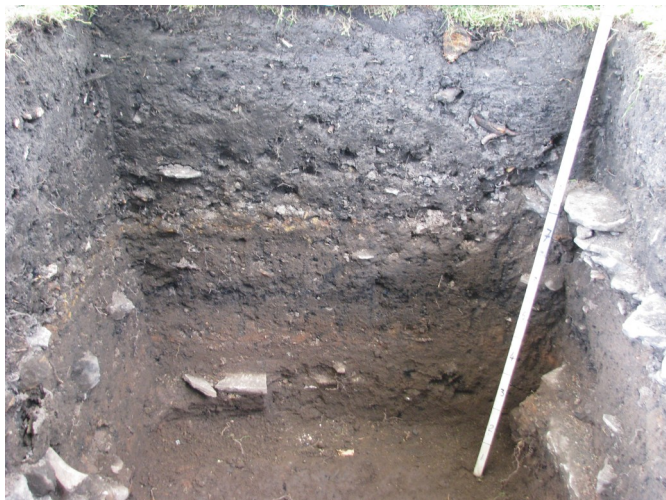
IMG\_1551 showing north face. Stones high in the wall on the left are the demolition layer. Red clay just below the dark, charcoal rich layer marks the position of the floor.

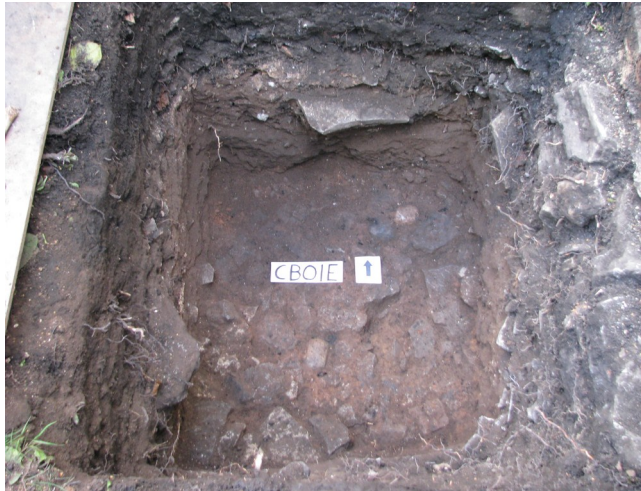
IMG\_1967 View N at c 70cm. First sight of stone floor feature with clay. The slate protruding from the north wall is a roofing slate from the demolition layer.

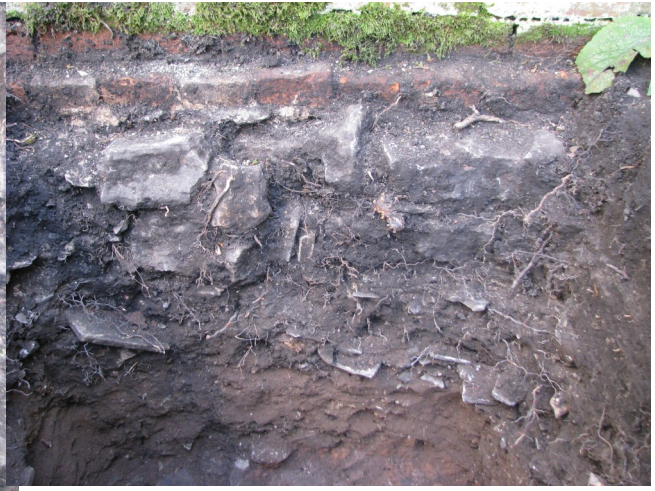
IMG\_1969 View E. shows the lower courses of the boundary wall. The demolition layer is just beneath it.

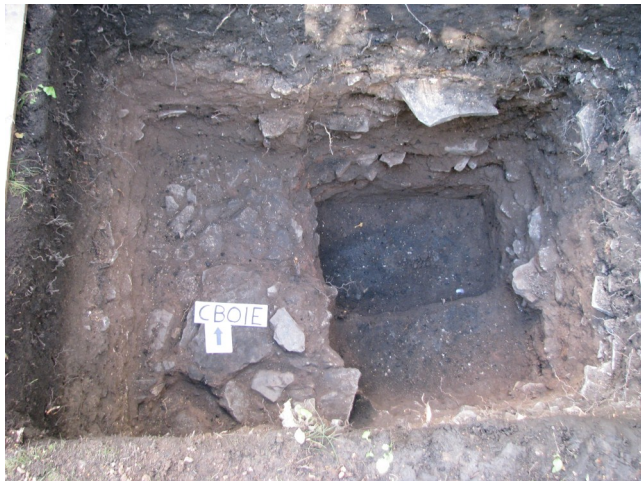
IMG\_1975 View N showing 50 cm pit extension to the west (left). The stone feature in the western half and the sondage dug through the feature on the east.

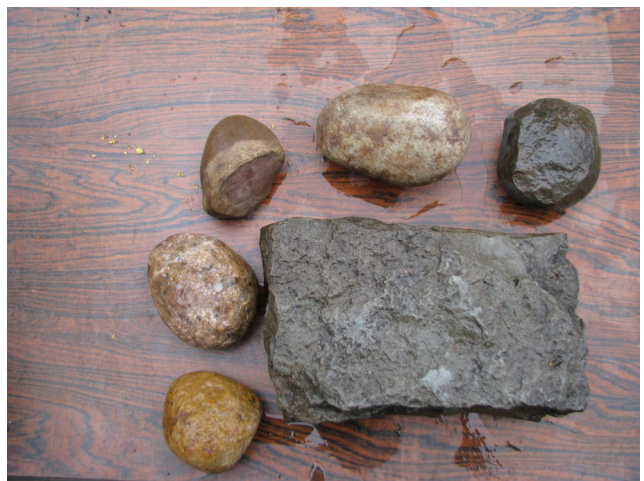
IMG\_1971 Some of the stones retrieved from the stone feature.
