HISTORICAL ARCHITECTURAL SURVEY, 16 CHURCH STREET

Seymour Cottage

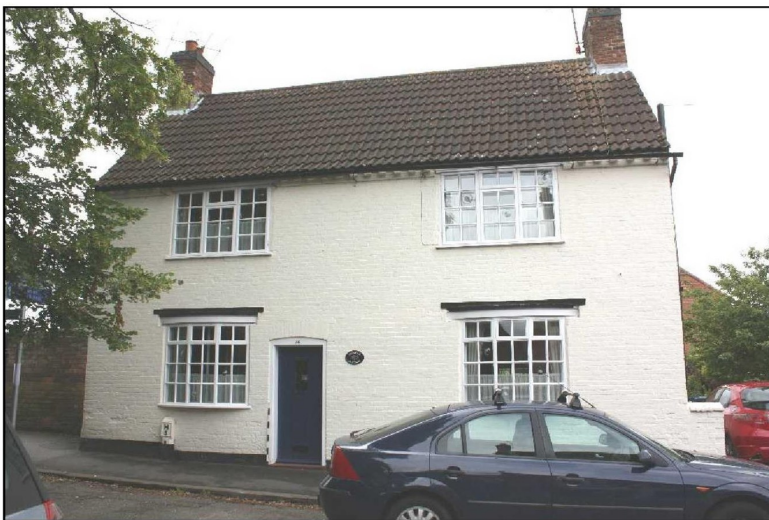
Number 16 Church Street is at the cul-de-sac end of Church Street where Church Lane starts on the south side of the churchyard of the Church of St Mary and All Saints. The building faces north onto the street (left) with an off-centre entrance doorway and canted windows (bay windows not reaching ground level) at ground floor. The east end (above, right) is set behind a brick wall boundary wall to Church Walk (between Church Street and East Street)

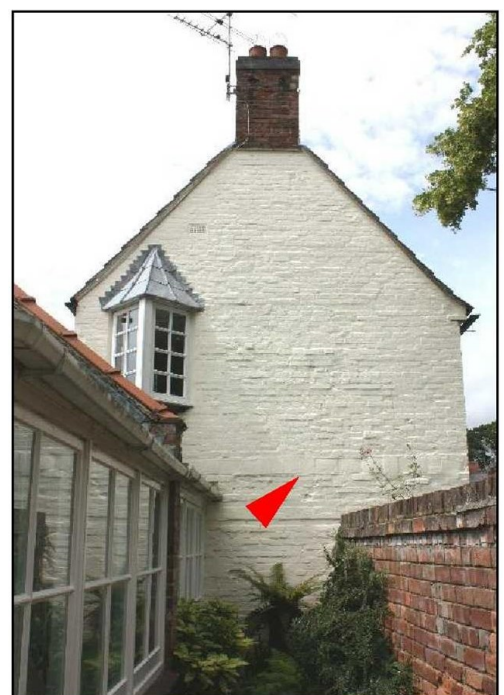
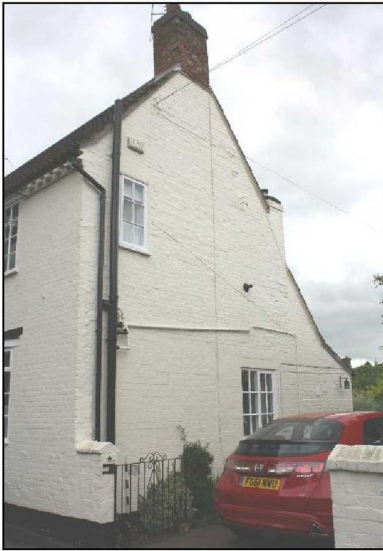
and at the west end (left) there is a side drive / parking area where the building once extended over.

The building is two storeys high (see right) with an attic and end stacks. It is principally brick-built with no obvious stone dressings, although what may be a course of stonework runs across the middle of the exterior of the east end wall. (arrowed in the photo on the previous page) The roof is covered with modern tiles and all the brickwork is painted white. There is some variation in the brickwork on the west and south sides, but the predominant brickwork is composed of bricks $2\frac{1}{4}$ - $2\frac{3}{8}$ inches (57-60mm) thick and $9\frac{1}{4}$ - $9\frac{1}{2}$ ins (235-241mm) long. This is laid in Flemish stretcher bond on the street frontage only, with the other walls being irregularly coursed. The north and south side brickwork is neatly laid (with the north side having a possibly added dentilation course at eaves level) but the side walls have a more irregular appearance.

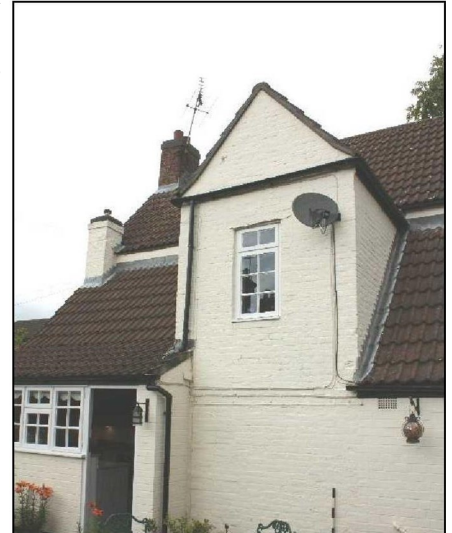
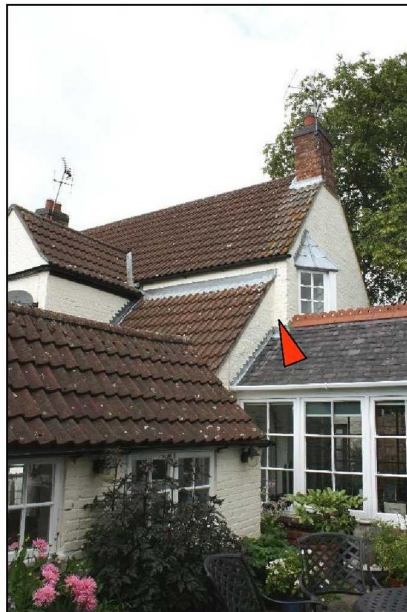
The building consists of a street-side two-room section, 9.5m long and 4.6m wide, and a rear stair turret extension with a gabled top that is about 2.4m (c.8ft) square. To either side of the latter there is a single-storey room with an angled roof. That to the left of the stair turret has been extended further out from the south face of the latter. The room to the right is on the same line and although its brickwork is not coursed into that of the turret (for reasons explained below), it can be seen to be coursed into the main part of the building near the latter's south-east corner (arrowed, left).

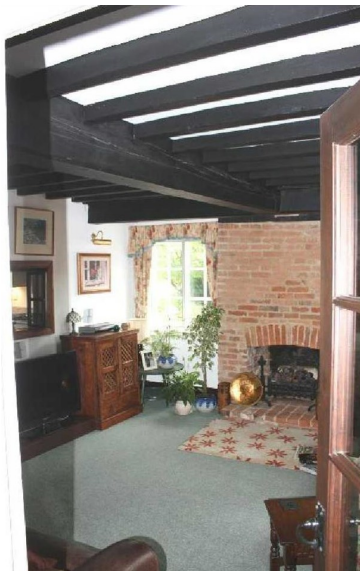
The interior is today much modernized and refurbished. The staircase turret (Room 3) now contains a metal

spiral staircase and the rooms to either side (Rooms 4, 5) contain modern kitchen units and a modern bathroom. Although the principal rooms on the ground floor have ceiling beams showing, these are not necessarily of any great age. The only exposed brickwork is the stack in Room 2 (left) and in the end wall of the bathroom (right). However, in both instances these may be examples of modern rebuilding. The windows and doors have all been replaced.

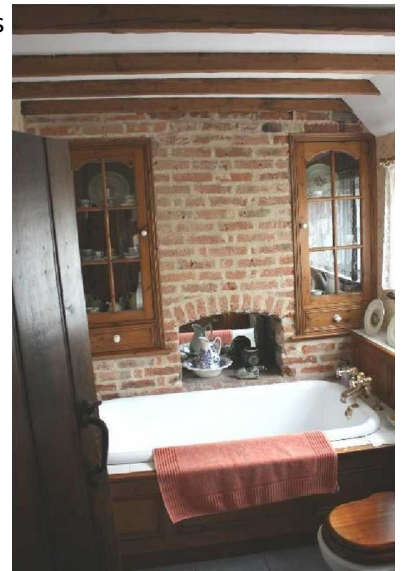
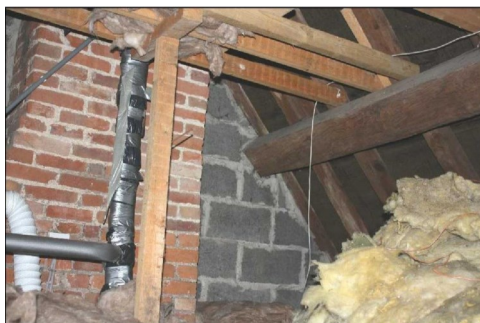
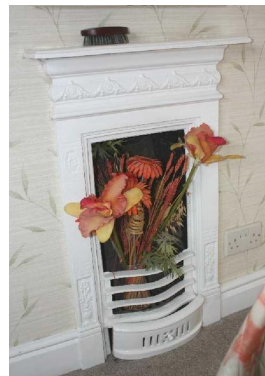
On the upper floor, in room 7, there is a small 19th century fireplace (below, right). The attic has replacement timbers and breeze-block showing in the west gable end (below, left). There is no cellar under the building.

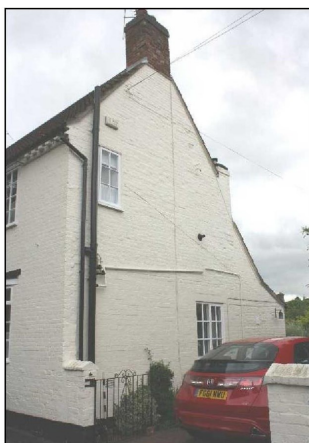
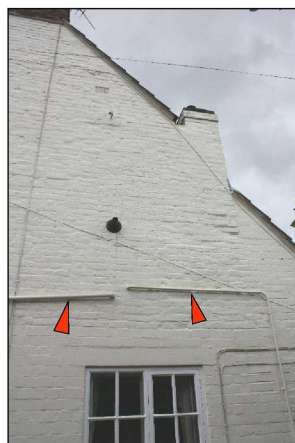
Much of the lower walling of the west wall (left) consists of modern 3 inch brick, presumably added at some point between 1840 and 1883 when an adjoining western bay was removed, or possibly a major repair in the 20th century. This brickwork extends beyond the back wall-line of Rooms 1 and 2, where it comes up against some early 2½ inch thick brickwork. The extent of this replacement brickwork was probably to allow for the insertion of the present side window and to replace thinner brickwork coinciding with a flue on the other side of the wall. However, above the 3 inch brick the unaffected higher level earlier brickwork also extends beyond the back wall-line of Rooms 1 and 2, where it is abutted by another phase of replacement brickwork forming

the upper level of Room 5 (arrowed, above right). This walling is curious as it also has straight joints showing at a point between ground and first floor level. The inner brickwork is similar to the surrounding but the coursing is off-set. The joints are also of dissimilar lengths and do not necessarily indicate a later infill. The upper west wall brickwork also includes a small chimney stack that rises within the north-west corner of Room 4.

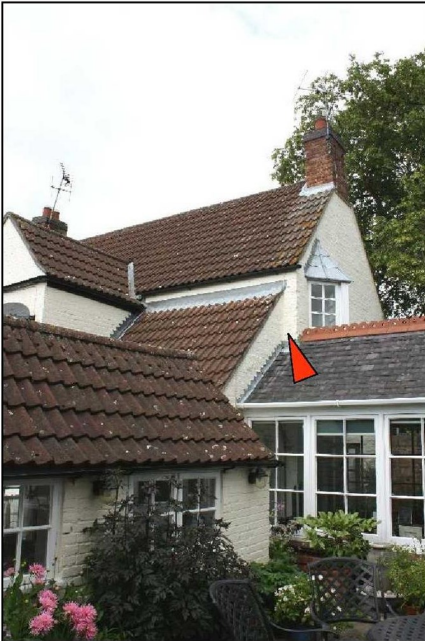
The brickwork join at the north-east corner is regular and counts against the refacing suggestion. Here the east wall is set at a slight angle to the rest of the building, reflecting the property alignments in this part of Bingham and showing that the building's position was constrained by a likely burgage plot boundary, which incidentally is aligned on the western boundary of the church. The south-east extension, Room 4, is stepped back and not quite in line with the east wall (perhaps to avoid having to follow the same angle), and it appears to be jointed into the back wall of Room 1 (arrowed, left) Why the outhouse, probably built at the same time as the house, extends further to the east is not clear.

The south elevation of the building has the stair turret to centre (bottom, right) with an upper window for lighting the inner staircase, and a gabled roof. Its walling is a brick-length thick, whilst the back wall behind Rooms 1 and 2 is only a half-brick thick. This is most likely a reflection of where the main timberwork was placed. The main beams ran the length of the building and were supported on the brick stacks. That in Room 2

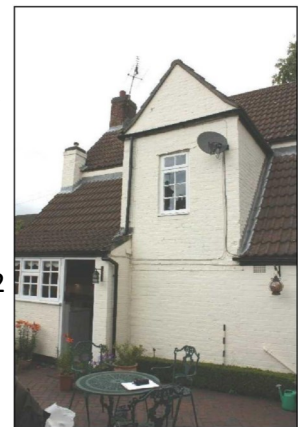
The back of Room 4 has been extended outwards to provide extra space for the modern kitchen it now contains. The upper side walling had previously been altered prior to this. The back of Room 5 is still on its original line but shows differences in the brickwork. Between its junction and the middle of its window there is 2¾ inch (70mm) thick and 9-9¼ ins (229-235mm) long brickwork. This is likely replacement brick infilling a former doorway and the insertion of the existing bathroom window. The 1840 plan shows an entry in the back wall of the building.
