HISTORICAL ARCHITECTURAL SURVEY, 16 MARKET PLACE

Beauvale House

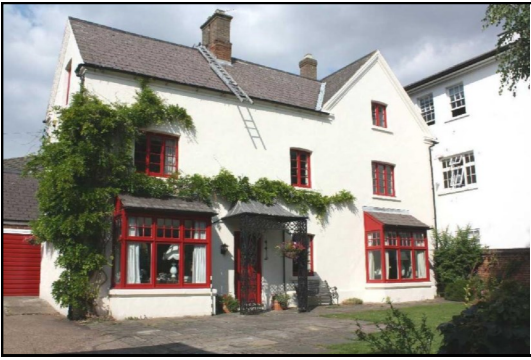
Number 16 Market Place is positioned near the north-west corner of Market Place, set back from the street frontage by a front garden, with a driveway on its left side. It currently faces south with an off-centre entrance

doorway and added bay windows (left and right). The building is two storeys high with garrets making full use of its lower roofspace. It is roughly of L-shape plan and is principally brick-built with no obvious stone dressings, although some stonework does show in the east wall of the cellar. The roof is covered with slates and there are four gable ends decorated by moulded cornices forming broken

pediments (left). The north-east part is a relatively recent single-storey addition (Room 7), now used as the kitchen.

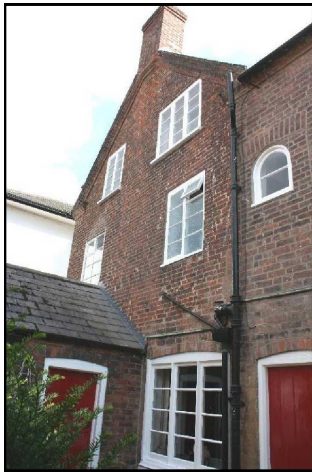
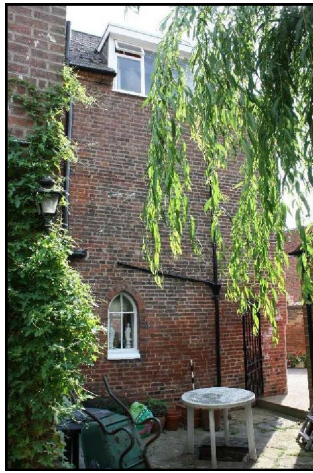
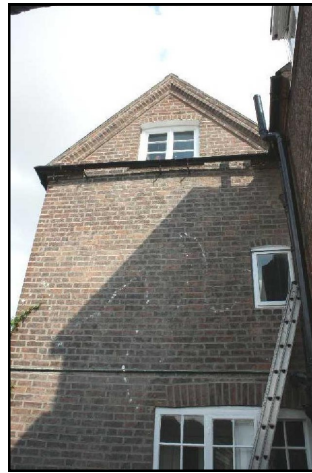
The south-facing elevation is now rendered over, whilst both west and east sides are painted white and the rear elevations are of plain brickwork. The rear elevations have a variety of window openings (below, left and centre), and whilst the south side has some semblance of symmetry, this side has evidently been refaced (groups of straight joints arrowed, below right). The lower part of the main east wall is unusually thick and may retain

stonework from an earlier building. (the original de Bingham manor house; see introduction) This wall is heavily rendered on the outside (left) and is part plastered over and part boarded on the interior. The wall's interior alignment is irregular, this being but one of several irregularities showing in the building's general plan, such as the angle of the west end.

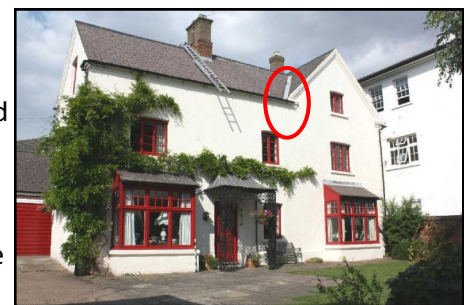
The 1840 and 1883 maps show the driveway as an access lane to the farmstead north of the house. The building is shown in its present-day L-shape plan, with an earlier extension at the north-east corner, since replaced. The earlier map suggests that the main frontage might then have faced eastwards, with a doorway indicated and an open approach from the Market Place on the east side of the building. Now approached from the south, the present frontage

of the building appears somewhat odd, with the west wing's east-wing roofline meeting the gable end of the east wing (circled, right). However, the present east side is heavily rendered at ground level, covering any traces of the opening or any adjacent windows, and with signs of only one former centrally-placed window at first floor level (now infilled). This side now faces a narrow alleyway (above, left).

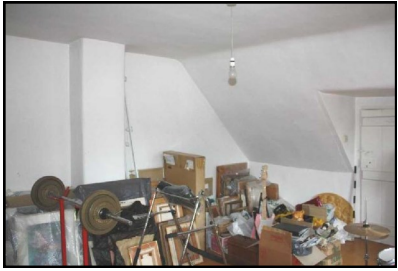
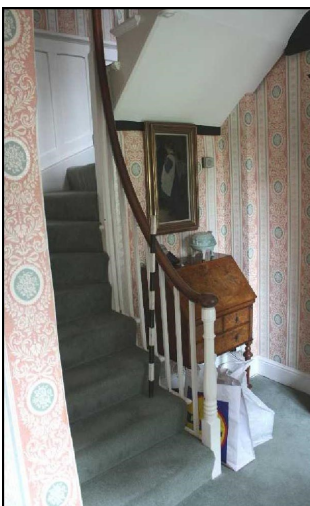
the east part might support its dominant status (along with the suggestion of having been the main east-facing frontage), but it has two rooms of unequal length, the shorter one of which (Room 4) has been used as a kitchen, a service room usually found in a rear wing. The west ‘service’ part now houses a lounge and the principal staircase, which leads off a wide entrance hallway. The three principal rooms have fireplaces, two being internal; the upper floors are now devoid of fireplaces. The stack from the fireplace in Room 3 rises as a narrow square-section flue through the two rooms above (see section, right and image, left).

Although the house has been refurbished and modernised it also has unlevel floors in several rooms and it retains a lot of exposed timberwork, especially at first floor level. These include chamfered principal beams that run the centre length of the rooms at ground level and then cross the rooms at first floor level. Some of these beams have been boxed-in. No roof timbers were accessible, although the evidence suggests the building has been fully re-roofed. Ten samples from exposed timbers were taken for tree-ring dating. Whilst the timberwork gives the impression that the building is of some age, the house retains few if any fittings that can be positively identified as original to the build. There are two intact fireplaces, a stylish main staircase (left) and 2, 4 and 6 panel and plank-built doors. Apart from a single gothic window all the others appear to have been replaced.

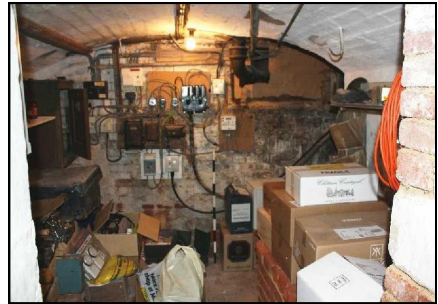
Figure 6: Cellar plan of Beauvale House, No. 17 Market Place, Bingham, Nottinghamshire. Scale 1:50 at A3.

The building has a small 2-cell cellar (Rooms 8, 9) with an arched roof and thralls (right). It has a central position and is reached down a flight of steps immediately under the back stairs that rises to the attic level. There is a suggestion of a former window at the base of the stairs (black arrow, left) but this is oddly positioned at a corner of the building above and would have provided angled lighting. Exposed stonework at the east end (blue arrow, left) might possibly be part of the base of a former stack to Room 3 above, since moved further to the east, or part of an earlier basement / cellar before the present

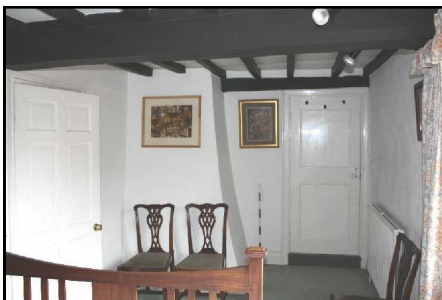
In the absence of dateable original fittings, dating the building largely comes down to its brickwork and to tree-ring dating. Whilst the latter has been hampered by an unusually high failure rate of 70%, a positive date of 1719 has come from the cross-beam in Room 11 (left), with the possibility that the north-south beam in the room below (Room 1) might be of comparable date. In Room 4 a common joist provided a date in the region of 1574-99.
