HISTORICAL ARCHITECTURAL SURVEY, 19 MARKET PLACE

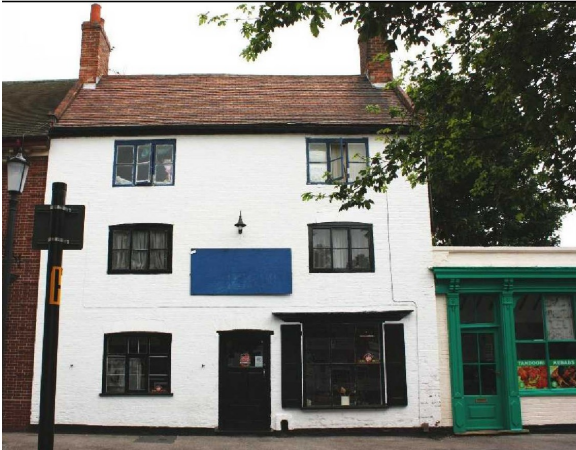
Number 19 Market Place is positioned on the north side of the market place at the centre of Bingham, east of where Station Road starts. The building is three storeys high with an attic and end stacks, and is fully brick-built with little indication of any stone dressings being present. On the south side the roof is covered by tiles, whilst the north side has slates. Front and back have been painted white, whilst the exposed east side remains clear. The east side reveals a catslide roof that is at a slightly less acute angle to the main roof above it. The side view also shows raised brickwork and kneelers on the street frontage and exposed timber leveling plates where the gable starts.

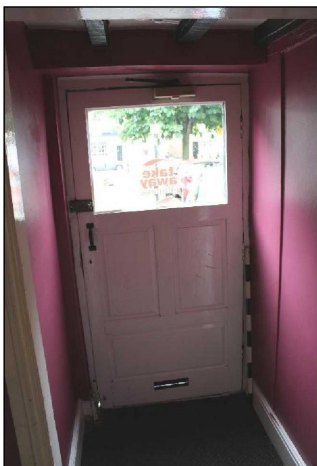
The street frontage is composed of 2¼ inch (57mm) thick and 9-9¼ ins (229- 235mm) long bricks set well in Flemish bond coursing (see left). The exposed side elevation is largely composed of stretchers, with headers only appearing at the corners and where the internal stack joins the wall. The street frontage has partial symmetry, with windows set at equal distances from a slightly off-centre doorway, and located in the same positions on all three floor levels. The ground floor right side window has been enlarged. The other windows are tripartite with a central casement and have frames that are set flush to the outer wall. The ground and first floor windows have arches over them.

The front door (left) has fielded panels (a raised or recessed panel) with a wide flat surface surrounded by moldings with a shallow one to base, suggesting that the door may have been turned through 180 degrees and the lower panel removed to take a window.

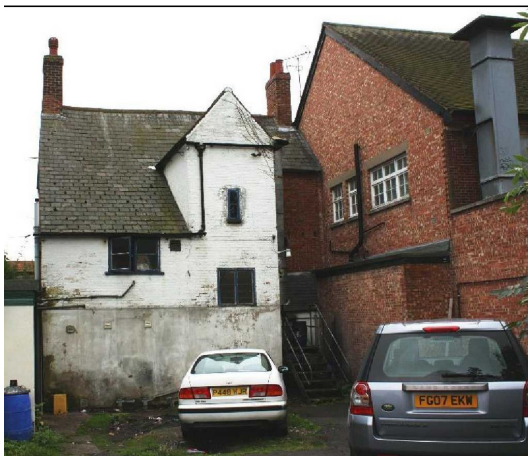
The rear elevation (below) shows this turret with a gabled top and central windows, the top one of which has been narrowed. The base of the turret has been rendered over and this has covered a third window lighting the stairway into the cellar. There is an

added cell with the catslide roof to its left of the turret and a lower addition, set-back to its right. Whilst the street walling is one brick thick, the side and back walling is thinner and floor joists can be seen exposed at the back.

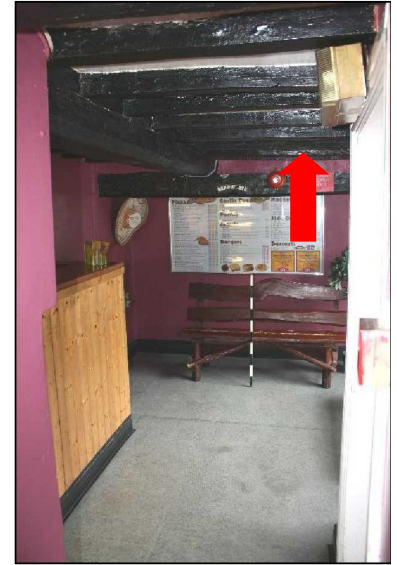
The off-centre cross-wall (arrowed, left) was aligned to the centre of the stair-turret where paired doorways gave independent access to either room. The west entry at ground and first floor levels have been infilled). Only that at second floor level remains in use.

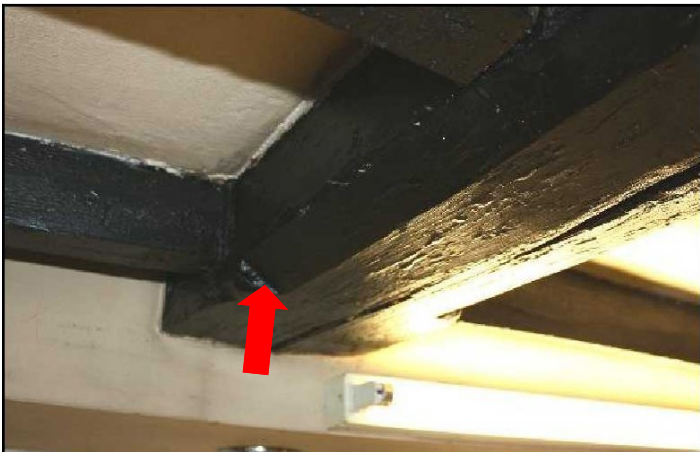
The central wall has been largely removed at ground and first floor level, being replaced by a central (red painted) brick pier and boxed-in timber or metal beams above where the wall had been (below, right, red arrow)).

At the west end of Room 1 a shallower fireplace stack has been removed, as indicated by the position of chamfer stops on a longitudinal cross-beam (left, red arrow).

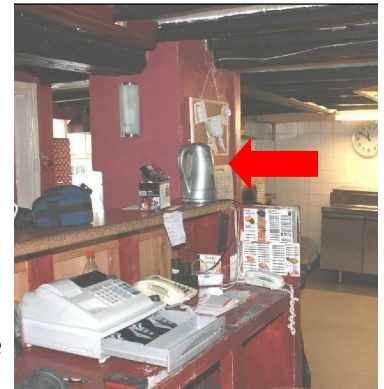
Two other rooms (4 and 5) were added alongside the rear stair-turret. These are currently used as kitchens and are heavily tiled so that little original structural evidence shows. The original entries into these parts have also been widened.

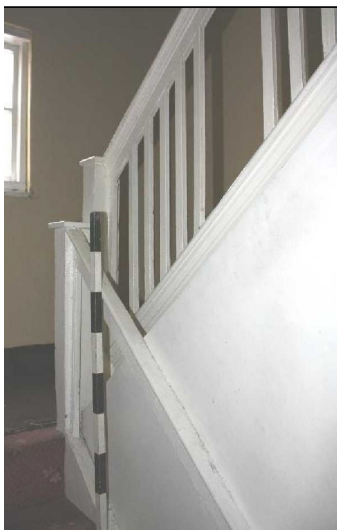
The rear stair-turret contains a dog-leg staircase with a lit rear landing between each floor. Each rise has 5 steps. The staircase (left) itself is of simple design and almost certainly not original. Many of the balusters are now missing. At the base of the staircase a door leads to a continuation down winding steps (see plan, below left) to an entry into a single barrel-vaulted cellar (right), whose position matches the window openings (see plan below right) on the floors immediately above. Although the sides of the cellar are now obscured by boards, there is no reason to anticipate any other cellarage under the building.

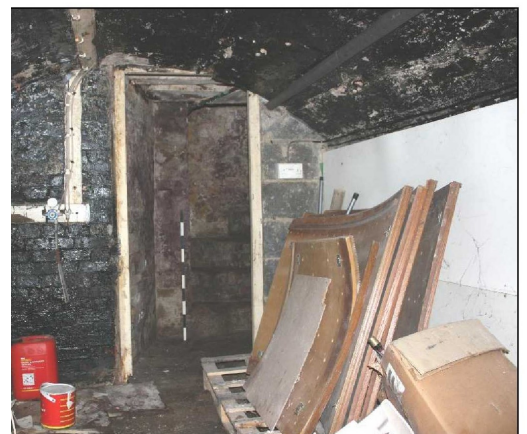
Similar barrel vaulted cellars are found in other houses in Bingham - The Manor House, 4 Long Acre, Norton Cottage are examples.

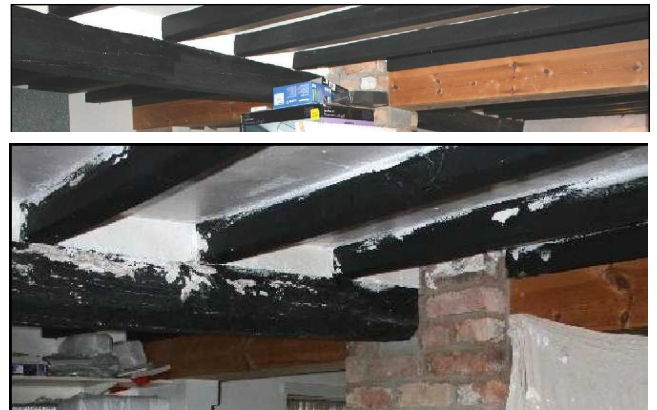
That on the right side was inaccessible but the left one contains a flue from a former fireplace below, situated either in the north-east corner of Room 2 or within the east wall of Room 4 (where the wall remains thick). This cupboard also has traces of possible original blue paint on its plasterwork.

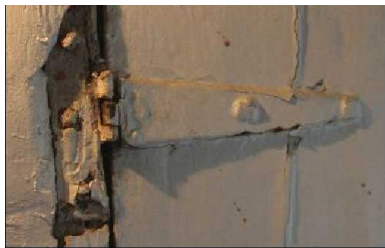
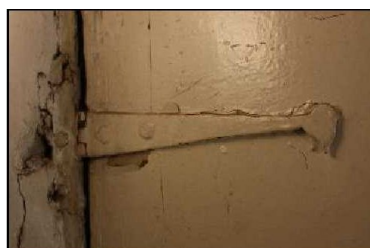
The doors have a variety of differing hinges which are probably of 17th or 18th century date (photos below).

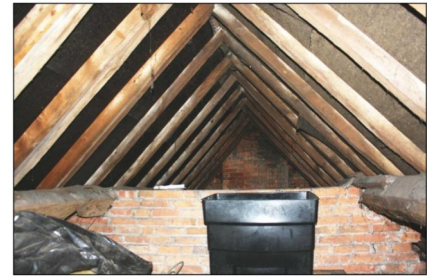
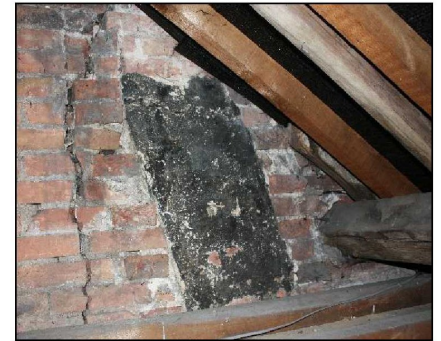
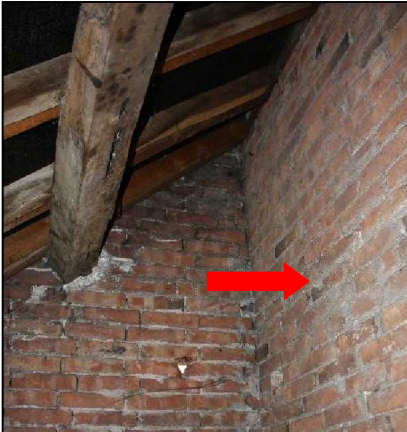
In the bathroom cupboard there is a hatch providing entry into the attic above the main part of the building. The roof (right) is composed solely of rafters and a single line of purlins (see plan, left) and has been rebuilt in relatively modern times. Although the roof over the stair-turret was inaccessible, it was possible to enter the roof above Room 9, which contains rafters supported by two purlins. That this part has been added to the original structure was evident from the brickwork. Although the bricks were coursed in at the join between the north wall of Room 8 and the east wall of Room 9, the former had the appearance of having been an outside wall face (arrowed left), whilst the looser mortar in the latter showed that this had been internal. Brickwork near the north-west corner of the stair-turret had cracked and been partly repaired (above, right). This might explain the evident rebuilding of the gable top of the stair-turret.
