HISTORICAL ARCHITECTURAL SURVEY, 21/22 MARKET PLACE

“Bingham Manor House”

BUILDING DESCRIPTION

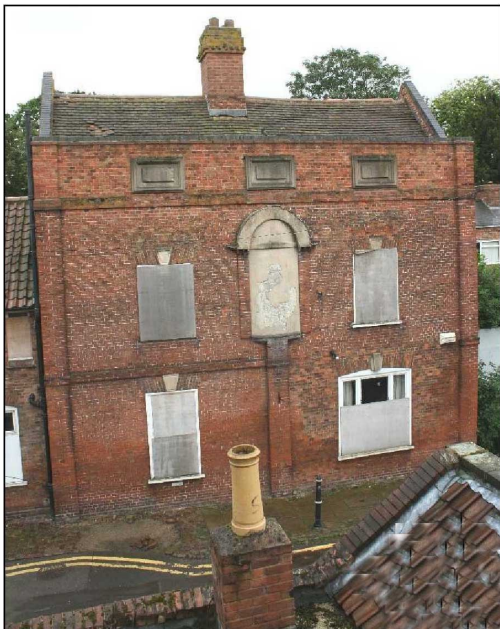
The most distinctive part of the Manor House complex is No. 22 Market Place (left), a Georgian-style building that faces west and stands prominent near the north-east corner of the Market Place. It is brick-built with stone and concrete dressings and has a gable-ended roof with plain tiles at the front and pantiles to the rear. It is of a 3-cell plan, comprising two rooms running north-south sharing an off-centre stack and, to the rear, a protruding stair-turret; later rooms were added to either side of this. The original plan is thus T-shaped, although rear turret part was not centrally positioned to the rear wall. In overall plan the building is (including pilasters) 10.5m (34ft) long and 8.4m (27½ft) deep. The turret itself is 3.1m (10ft) square.

The west street frontage has two corner pilasters and a shorter one beneath a central panel, two string courses and a parapet featuring three panels. There are four windows with gauged brick flat arches and projecting keystones; the bottom right window is an enlarged replacement

of the original one.

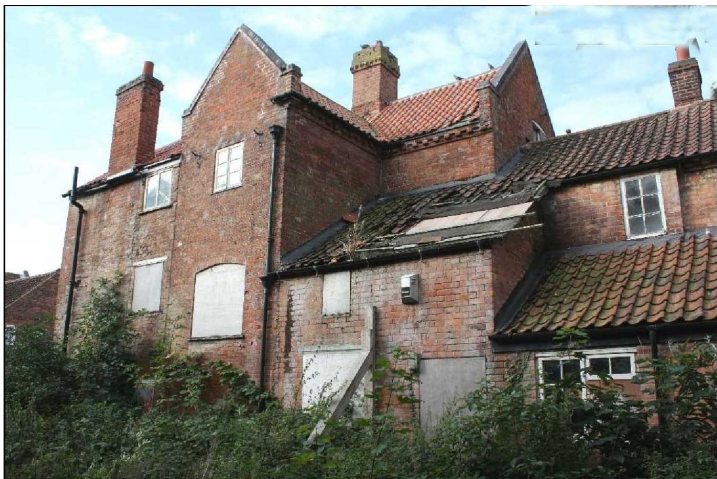
The brickwork on the side and rear elevations is different with headers and stretchers laid in irregular coursing, the bricks being about 2¼ inches (57mm) thick and 9¼ ins (235mm) in length. The east side, the stair turret and the central stack feature a dentilation course. The gable ends of the main range and the turret are raised and topped with modern blue and red brick courses (left). The north side of

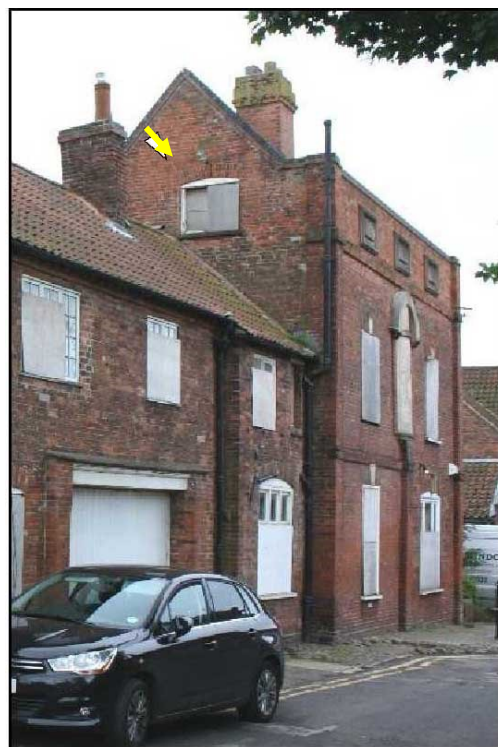
the main range only shows above an adjoining lower structure and here it includes a garret window. Brickwork around this suggests that the present window with its segmental arch has replaced a slightly wider one with a higher arch with flared ends (arrowed, right). The full extent of the south side is now exposed and here much of the brickwork has been replaced at ground level when a window, similar to that at the front, was inserted to provide additional lighting to the south room (arrowed, left). The garret at this end was also lit by an off-centre tall window, whose original arch with flared ends still shows.

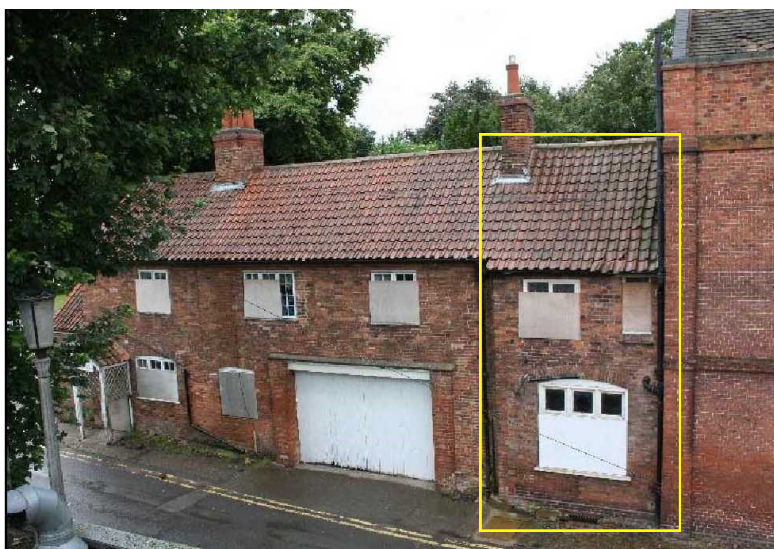
Part A2: Adjoining the north side of A1 there is a two-storey tall building, one room/cell wide which, whilst set back from the west face of A1, nevertheless projects forward from the building extending from its north side (outlined in yellow, left). Whilst its appearance and brickwork are similar to the latter, it is internally connected to A1 and not the building on its north side (Part B); it is here designated part A2. On its west side it features a large window with a segmental arch and two smaller windows above it that light a bathroom and a WC. The ground level brickwork is 2¼ inches (57mm) thick and 9-9¼ ins (229-235mm) long, whilst the upper

brickwork is thicker; this discrepancy is discussed further below. The east side of this addition has its upper brickwork (containing a window) exposed; this was rebuilt when parts A4/B4 were added (see below).

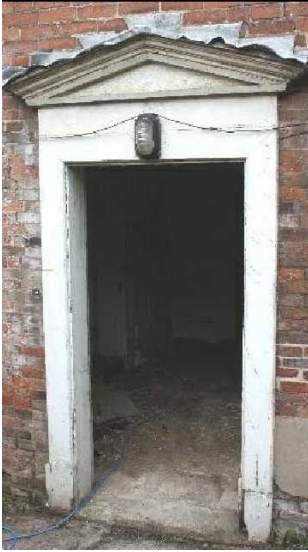
Part A3: A single-cell was added at the south-east corner of the main structure (right). This is slightly set back on the south side and it appears to abut the original build with only a few bricks acting as ties. The addition is three storeys high with its upper floor levels lower than those of the adjoining structure. At ground level there is a south-facing entrance with a classical pediment (left). The bricks at lower level on the south side are 2¼ inches (57mm) thick and 8⁷/₈-9¼ ins (226-235mm) long on average, but the brickwork above the doorway is of finer quality and thicker at 2¾ ins (70mm). On the east facing side the thinner, poorer quality bricks extend to a greater height. Whilst the south wall is one brick thick the east wall is only half-brick thick and it may have proved safer to rebuild much of the former rather than the latter.

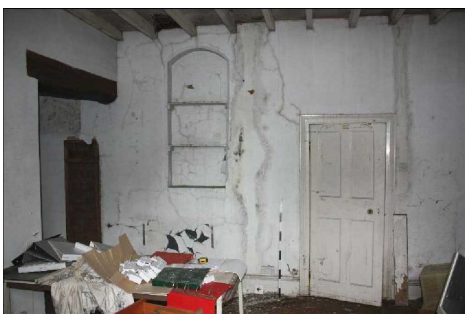
The Georgian building has at ground, first floor and second floor / garret level two rooms of unequal length that are separated by an off-centre space containing a stack, cupboards and recesses and, on the east side, an entry space leading off from the stair turret (Area 3). The main rooms are both 4.6m (15ft) deep and are, respectively, 4.8m (16ft) and 3.55m (11½ft) in length. The ground floor rooms are 2.85m (8 feet 4 inches) tall and the first floor rooms 2.76m (9ft) tall. The garret level to ceiling was 2.15m (7ft) tall. The turret is 2.8m (9ft) deep and 2.5m (8ft) in width. All six rooms were heated by back-to-back fireplaces set in a central stack 1.3m (4ft) thick. The principal rooms were lit by single sash windows in the west wall, whilst the uppermost rooms were lit by single windows in the end walls.

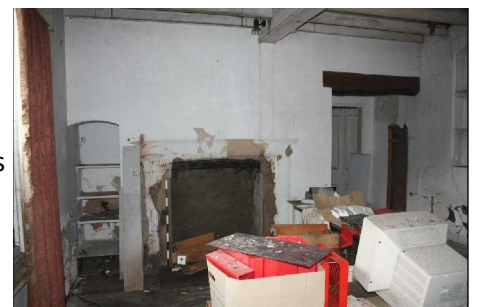
Rooms 1 and 2 at ground floor level were originally accessed through a near-central lobby next to the stack which one entered through a doorway from the stair turret. This doorway has been blocked off and new doorways created in the east wall of both rooms. The lobby provided direct access into Room 1, whilst another

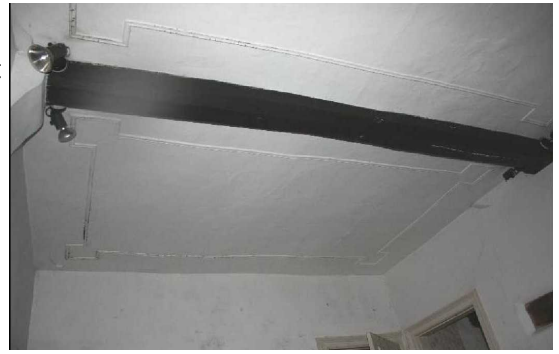
high ceilings. In Room 1 the first floor beam and joists are exposed and are probably replacement timbers. The ceiling of Room 2 is intact and bears a simple moulded decoration that is probably original. It is supported on an irregular chamfered cross-beam that rests on a corbel in the north wall (right).

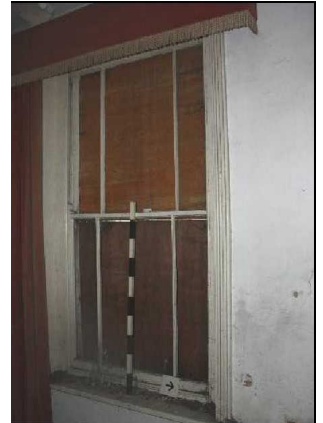
Both rooms have fireplace openings showing but lack the actual fittings. That in Room 2 (left) is wide and not untypical of a kitchen with its long timber lintel and small cupboards to one side. A high level cupboard retains a panelled door with a lock and may have been a spice or valuables cupboard. Room 2 has a sash window, whose upper and lower parts both have a single large pane and narrower margin lights; this is so-called 'Oxford' glazing is from the second half of the 19th century (right; Chapman 1998). Room 1 has two larger windows that have been added during the 20th century.

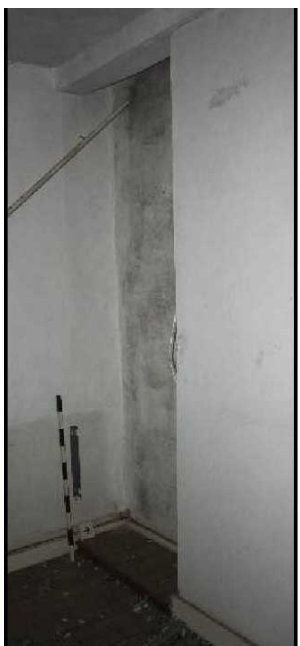
The first floor level is reached from the rear stair turret (Area 3) which houses an open well staircase that is made from softwood and appears to be of 20th century date. This is lit from two windows in its east wall (left). Off the staircase an arch straddles the entrance lobby to the bedrooms (Rooms 4, 5), with a storage cupboard standing between them (right). The cupboard's doors and those to the bedrooms and a connecting cupboard in Room 4 are doors with two fielded panels, probably of 18th century date, attached by L-shaped hinges. Both rooms have had the fireplaces removed and the openings filled in. The rooms are tall, like the rooms below them, and each is lit by a window similar to that in Room 2. In Room 4 there is a recess in the north-west corner with a slightly higher floor area. A line in the west wall suggests that the walling may once have continued across (left), although the cupboard space in Room 5 behind here gives no indication of any alteration, or evidence that the niche showing at the front of the west wall had once curved inwards and extended beyond the back of the wall.

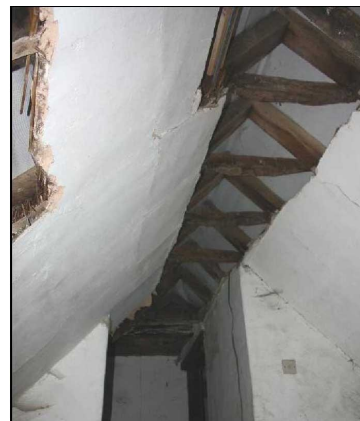
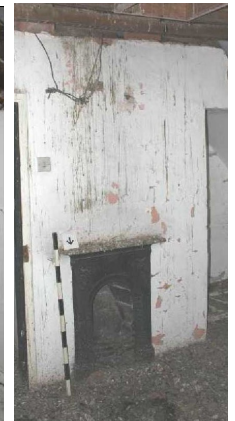
The staircase rises to a second floor/garret level and to an entry hallway leading to Rooms 6 and 7. A series of small timber trusses are exposed along the hall, with the timbers held together with pegs (right). Both rooms have doors like those on the floor below and Room 7, the smaller room of the two, retains

a bedroom fireplace (far right). The rooms are partly within the roof-space, with longitudinal purlins running on either side. Upper roof timbers now exposed would have been hidden by now lost ceilings. A loft hatch shows in Room 6.

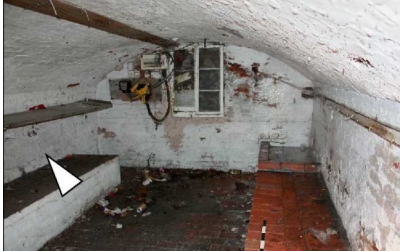
The cellar (left) is sizeable with its walls just stepped in from those above ground level by a matter of inches, giving dimensions of about 3m x 5m (10ft x 16½ft). It has a barrel-shaped roof and low thralls on either side. It was lit by a now blocked up sunken light in the west wall. A straight joint in the east wall suggests that there may have been a recess under the stairs and that the thralls may have been added later.

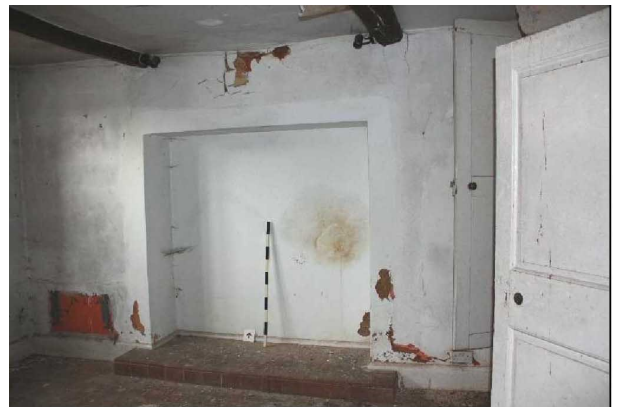
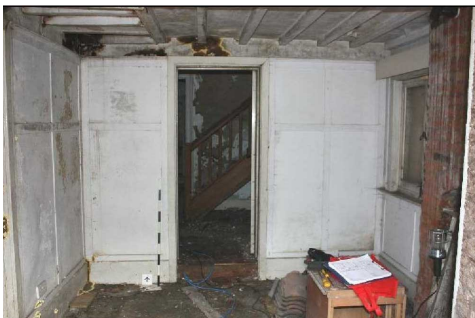
The ground floor room has a wide fireplace and is lit by a large window in the west wall. Its ceiling height is low compared to the adjacent rooms in A1 and it has two exposed ceiling beams (right). Access to this room is through an inserted doorway in the north wall of Room 2, from along a corridor from the stair turret or a back entrance in parts A4/B4; there is no street access. The upper rooms are reached up the steps and through another open arched-over entrance (as in A1).

The addition A3 in the south-east corner of A1 provided a heated entrance lobby on the south side of the building, entered through a wide door with a pediment above it. This has a paved floor, high skirtings, panelled walls, a fireplace and exposed floor joists (left); there is also serious dry rot. The two floors above it are set at levels to match the stair rises and have both been used for bathrooms in recent times.

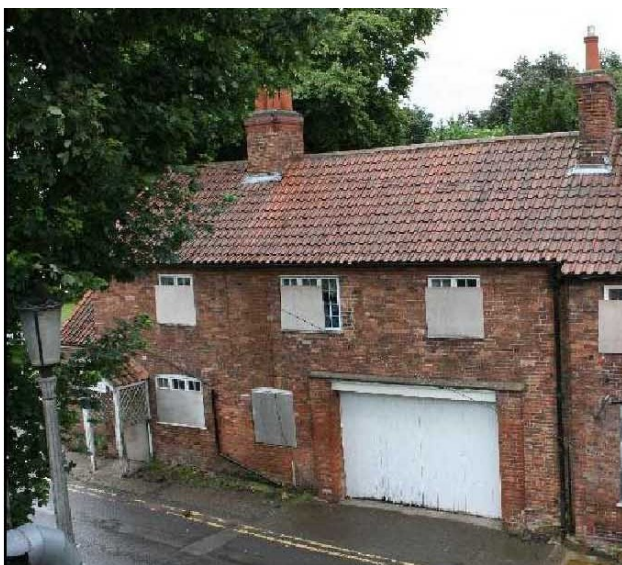
This structure is here subdivided into sections B1-B4. It may once have been a discrete unit, possibly two adjoining small houses / cottages in earlier times (B1, B2), later modified by the creation of a garage (B3), and the rebuilding of much of the first floor level. The west street frontage features a wide garage door in the centre of the façade, its doorway set between protruding brick pillars with rounded corners (left). To the right of this there is a short stretch of relatively thin bricks, 2-2¼ inches (50-57mm) thick and 9¼ ins (235mm) long, laid in English garden bond. To the left of the garage entrance there is a longer stretch of bricks of similar dimension but laid in an irregular manner.

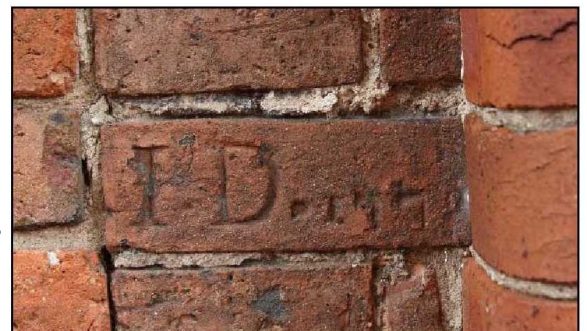
Just left of the garage pillar there is a straight joint that may indicate the left jamb of an infilled window; one of its dark bricks is inscribed with initials I.D. and the date 1778 (right).

PHASE 3: A few alterations are likely to have occurred in the later 18th century, perhaps all in 1778, the date on a brick in what may be a small infilled window in part B (mentioned above). The initials I. D. probably stand for John or Jasper Doncaster, the latter being a Bingham bricklayer who died in 1779. He evidently carried out some alterations that may have included the building of a heated entrance hall (with extra bedrooms above) to the Georgian house (part A3). This has a pediment over the entrance, possibly moved from an original position at the stair turret. This moved entrance may provide further evidence for an adjacent through-passage from Market Place as its position butts up to the narrower north end of plot 28 shown on the 1840 map.

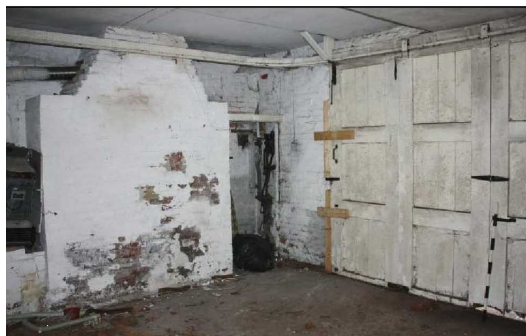
The south end of Part B is unknown as the building of A3 may have entailed the removal of its original end. Although it is not wholly clear, the thin wall separating the two structures (which includes a wide stack) is probably structurally part of A3 as it has the north cellar beneath it. The ground floor area is now separated into a single narrow room (12) and the garage space (B3; Room 13), which features the back of the stack of the fireplace to Room 18, a low thrall and a water pump (left). The concrete floor, the north wall and an entry in the east, back wall are contemporary to the garage entrance in the west wall. Part of the original north wall of B1 still survives at the north-west corner. A gap separates this from an end wall fireplace

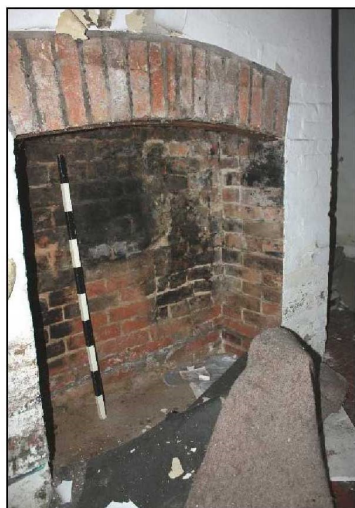
composed mainly of 2¼ inch (57mm) thick bricks (left). Another fireplace was added to the back of this when part C was added (right).

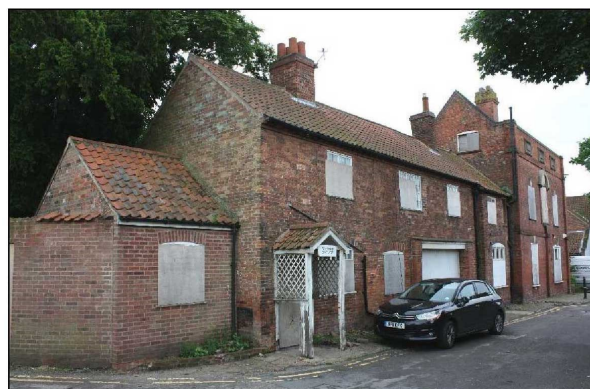
The north end of the street-fronting part of the Manor House complex consists of two cells, C1 and C2 (right). The former is a single room added to part B, two storeys tall and with a porch entrance to the street that has a nameplate *Manor Cottage*. The lower brickwork is 2⅝ inches (67mm) thick and 9-9¼ ins (229-235mm) long, whilst the upper brickwork is part of the later rebuild previously mentioned. Part C2 is a single-storey cell added

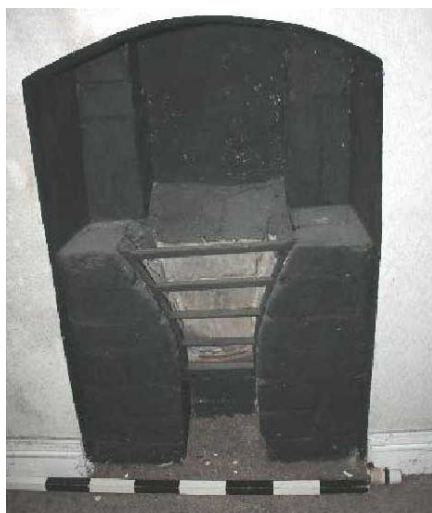
The ground floor interior of C1 (Room 11; right) has been opened up to incorporate C2 (Room 14). There is a straight flight of stairs to the upper floor and a low plank door to the below stairs area which appears to have been reused from elsewhere. In this space there is earlier brickwork showing in the back wall (not covered by plaster as elsewhere) and evidence of a brick floor surface 25cm down made of bricks 2¼-2½ inches (57-63mm) thick, suggestive of a late 18th century date. On the upper floor there is a single bedroom (Room 15) with a fireplace (left).

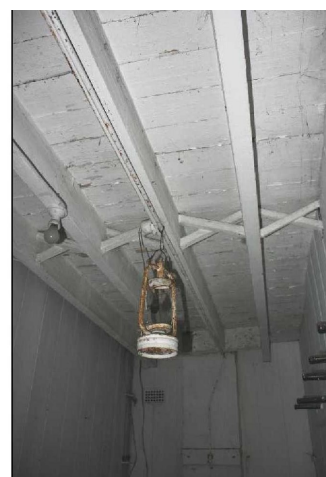
The ground level area was divided into two parts by a brick thick wall which appeared to have a blocked doorway at its south end. Whilst the north area was inaccessible to the writer, the south part had several small rooms, including a narrow room (27) with a small fireplace at one end, vertical timber panels (Plate 38) and a ceiling with scissor bracing (Plate 39). The room also has a line of pegs on one side and was most recently used as a WC. The upper level has a wooden floor and is largely still open and spacious (Plate 40). At the west end there is an opening through into the house and here a kitchen and bathroom have been created.

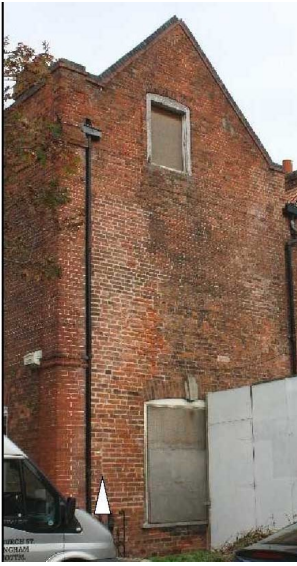
indeed be structurally connected. Where a comparable building has been removed next to the south side of A1 there is clear evidence for extensive brickwork repair that includes a straight joint where walling was probably tied in (arrowed, left). The contrast between A1 and A2 results from the sequence of building and the different design elements, rather than any necessary major difference in date. Part A2 was probably used as a kitchen and although the present doorway between Rooms 2 and 18 appears to be a clumsy later insertion, it may be an enlargement of an original narrower entry. It is unlikely to have been a self-contained service room. There may have been an external access point near its south-east corner allowing independent access to the large cellar, perhaps from an external brewhouse.
