# HISTORICAL ARCHITECTURAL SURVEY, 37/39 LONG ACRE

## (The Old Post office)

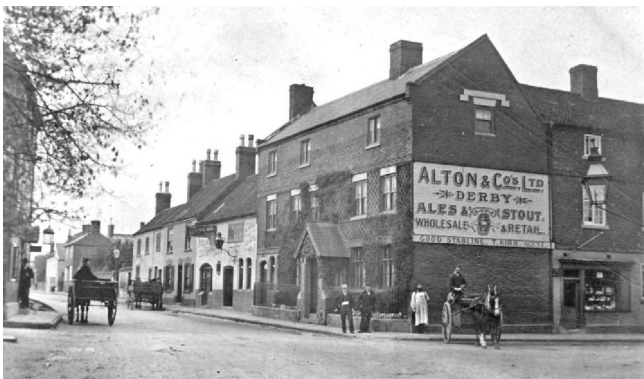
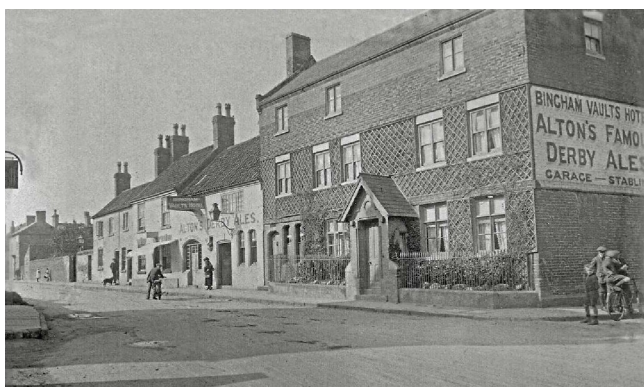
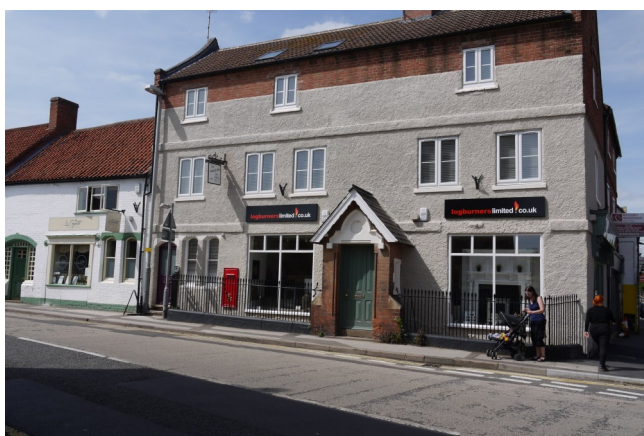
The old photographs (below) show no. 39 Long Acre around the time of 1900 and at this time the adjacent property of no. 37 was a public house known as *The Vaults Inn*, or the *Vaults Hotel*. Although early census returns for Bingham fail to give house numbers it is possible that in the returns for 1891 Henry Johnson was resident at no. 39, when it and no. 37 were probably connected and tenanted as one property. Johnson is listed as a wine and spirit merchant on Long Acre West and in Wright’s Directory for 1894-95 he is listed as landlord of *The Vaults*. In the 1901 census a certain Samuel E. Coleman was in charge of the *Vaults Inn* and Hotel, with its address then given as Market Street. The Vaults as a name is clearly derived from the cellar beneath the east part of no. 37.

In more recent times the west part of no. 37 has been the town’s post office reception area and Room 3 of no. 39 has been used as a post office sorting office. The frontage of both parts predates this use and dates back to the 19<sup>th</sup> century.

Room 3 then had an independent street entrance which may have been to an off-licence or the boarding house / hotel reception; it has since been blocked-up and hidden from view. The ground floor is now a modern retail unit (left, bottom) and has reinstated the doorway.

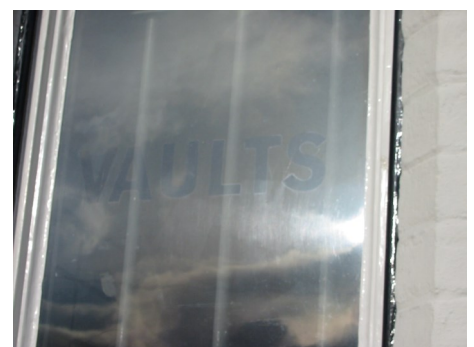
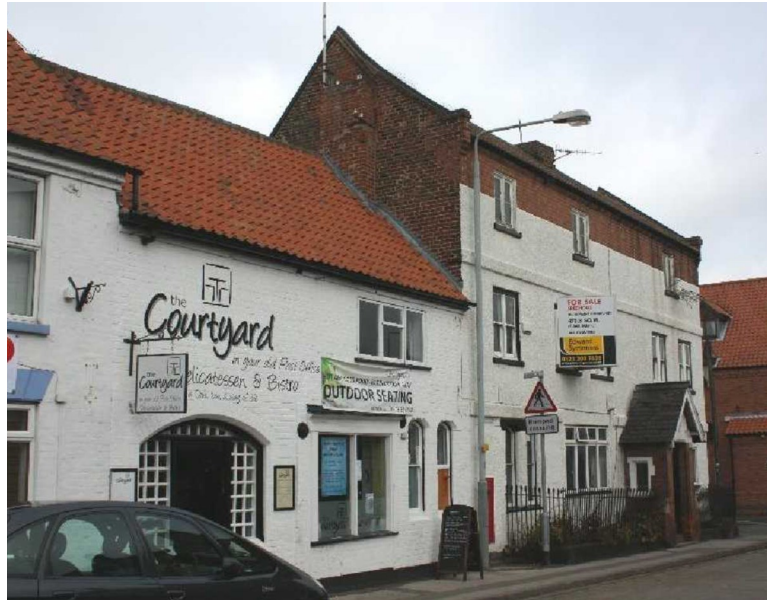
Number 39 Long Acre is positioned on the north side of the long standing main east-west thoroughfare through Bingham, at the junction with the road leading to the town’s market place. The building is two storeys high with a high attic/garret level, since raised on the south side facing Long Acre to present the appearance of a third storey (See vertical section below). The building is brick-built with some stone dressings, but no stonework evident at foundation level. The two sides facing Long Acre and Market Street are heavily rendered, although not to full height (below, right). Earlier views (above left) of the building show it before the render was added. These street-facing sides also have two slightly projecting

string courses, the lower one cut back where windows have been replaced and heightened. The main part of the building running along Long Acre is about 6m x 14m in size, five bays long and is slightly irregular in shape, reflecting the angle of Market Street and the former boundary with the neighbouring property, no. 37. To the rear there is a lower 2-bay long extension about 4.5m x 7.5m in size.

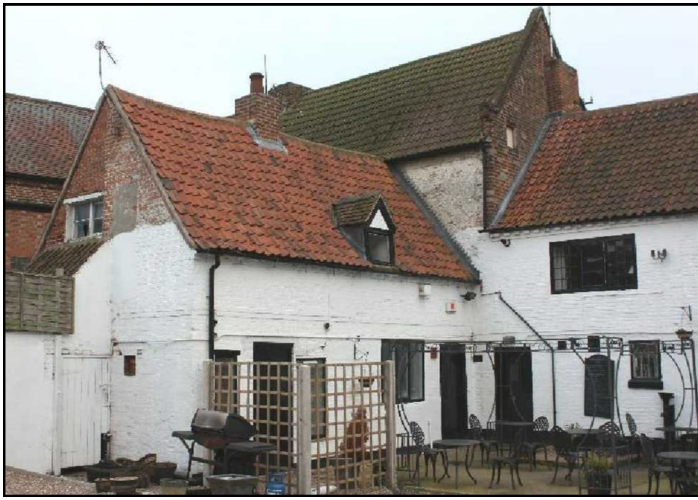
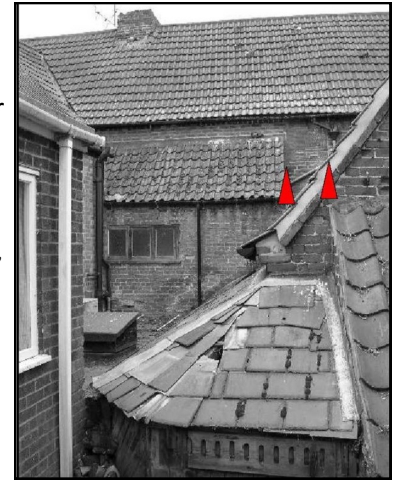
On the north side (left) there is a smaller and lower extension, its apex meeting the base of the main part's roof. This has a steeply pitched pantile roof, dentilation course at the eaves, a central stack and an added dormer window capped with plain tiles. East of the extension there is a side corridor (below), brick built with a timber superstructure and an angled Welsh slate roof; it runs from a rear entrance in no. 39 to the yard behind no. 37, and curves at a corner angle. To the east of this,

what remains showing of the rear elevation of the main part of the building, between the extension and the adjacent building on Market Street, is largely hidden by a narrow staircase turret, lit from the north side at two levels. Just beyond the top right corner of this an infilled former opening can be seen in the back wall,

which may be where a former dormer window provided light to an inner attic room. (arrowed, above, right)

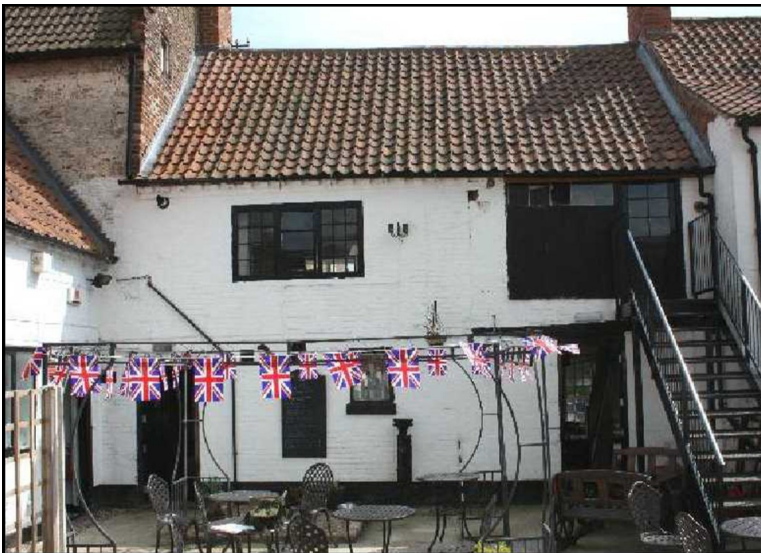
The adjacent property, no. 37 is two storeys high with a lower roofline than its neighbour (left). On the rear elevation a straight joint shows between the two buildings at first floor level but lower down the brickwork of no. 37 has been altered and is coursed into that of the north extension to no. 39, indicating perhaps a common ownership at that time.

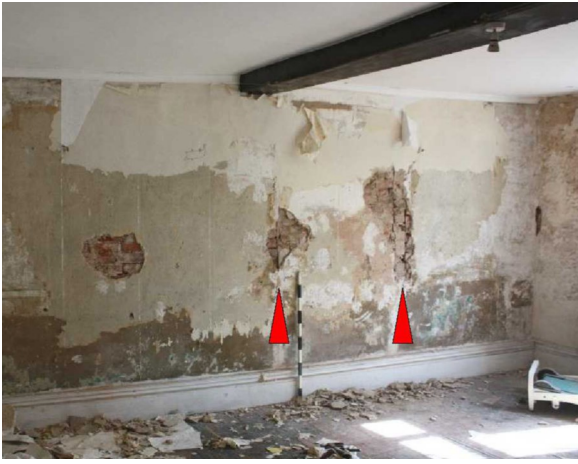
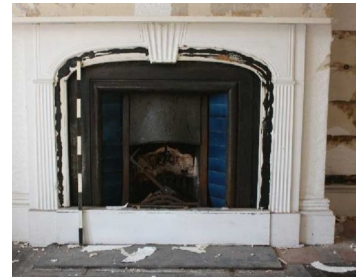
## Room 1:

A large room with a cross-beam and wooden floorboards (left). Heated by fireplace with a surround in early 18th century style with 'keystone,' and a grate with classical motif (right). The east wall has an infilled former doorway (arrowed, left), revealed when plasterwork was removed. The rough edging suggests it is not an original opening but has been added (perhaps to allow the room to be used as a shop), and then subsequently blocked-up. This infill can be seen on the old view (arrowed, right) [which also

hints at a former window towards the north-east corner of the room where a timber(?) sill was noted under the plasterwork. [T Kirk (bottom of the painted sign) was the landlord in 1904 and 1908 directories].

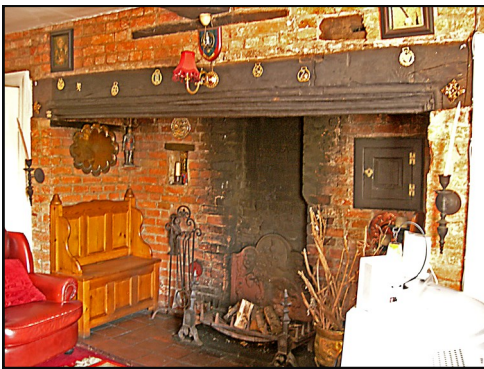
## Room 2:

The room is dominated by a large inglenook-style fireplace, (left) with bressumer beam 11 feet (3.34m) long with a hollow and double ogee moulding (right). Exposed brickwork above the left side and the downwards return on the right indicate that the bressumer may be a later insertion. The fireplace had a 'laughing lion' fireback (right)

with date of 1644, but brickwork to right has been cut back to accommodate it and it is more than likely not original to the fireplace; firebacks with this design were not uncommon in the 17th century and this one may be one of the many 20<sup>th</sup> century copies. Two small recesses in back wall for cupboards and added tiles to support corner lights.

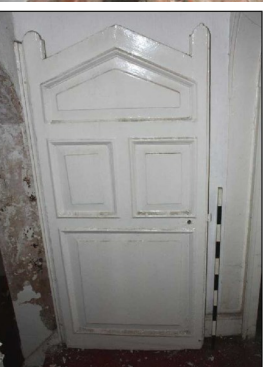
The room is crossed by beam with heavy chamfer and chamfer stops (left). The west wall has a bricked-up former opening into Room 3 by the north-west corner and a later opening near south-west corner is also now blocked-off. A low three-plank door standing next to this opening looks early.

The fireplace has provided an ideal vehicle for displaying the of products sold by the new tenants (right) .

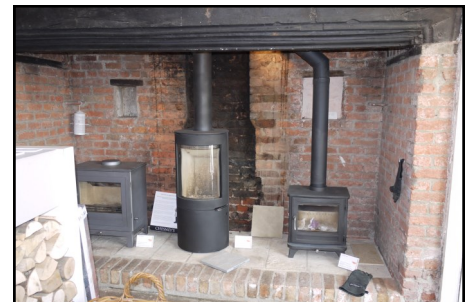
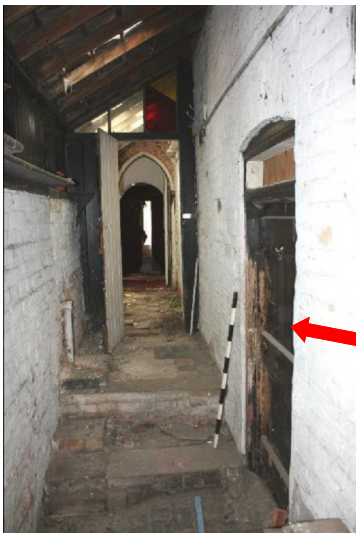
There is a modern replacement window in the south wall and two entries in the north, one formerly into the north extension, the other has a three step raise to the stair turret and corridor. Although the latter entry has a rounded head, the door here is an early 18th century style panelled door with an unusual triangular head and side projections (left). The head was made to look similar to a pediment above a doorcase . The back of the door has an 18th century style heavy latch (right).

At ground floor level beyond the staircase, an added doorway with a gothic arch and door (right) opened into the corridor which runs alongside the north extension, dropping down three steps close to a blocked side entry into the extension (arrowed, left). Unfortunately neither door could be retained after the re-development.

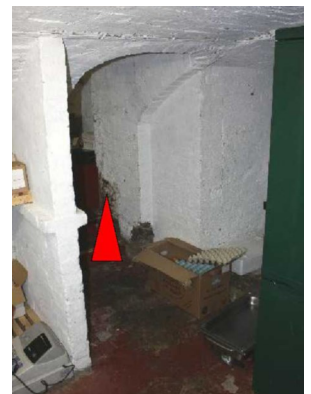
### Room 14:

Beneath the staircase another flight descends into a single cellar immediately below Room 3). This is an open space with no thralls and a flat ceiling, unlike the cellar under no. 37 which is barrel-vaulted with side partition walls. A break through the side wall gives access into the neighbouring cellar, the connection suggesting that the latter is later and was built with an arched side for access to Room 14 (arrowed, right).

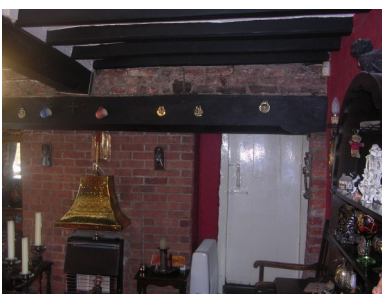
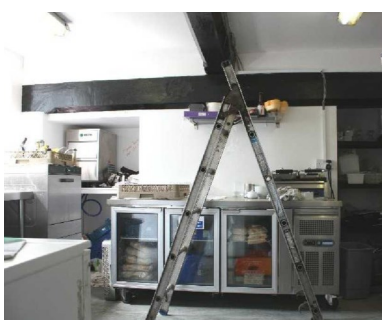
### North extension Room 10:

Probably a former kitchen. Prior to the survey the fireplace had been blocked up (left). The three plank door gave access to the rest of the extension. That entry has been recovered since renovation but unfortunately without the plank door. The fire place with side recesses, was (is) overridden by long chamfered beam running the full length of the room. The doorway from Room 3 is narrow and is clearly cut through the existing wall when the extension was added. Both the bressumer over the fireplace and the longitudinal ceiling beam have heavy beams chamfers. Before the recent renovation as a cottage, this room was used a commercial kitchen (bottom left).

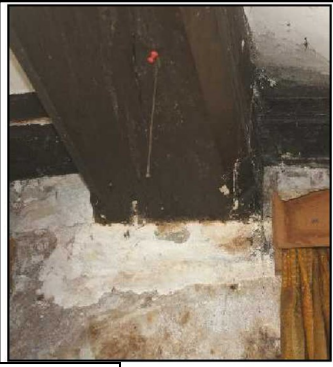
Evidence in a side wall of the ceiling level of Room 4 having been raised.

This room, the largest of the bedrooms on the first floor, has a bridging beam and joists exposed (right), with indications in the walling that the ceiling has been raised by about 4 inches (100mm; photo below). This probably coincided with the installation of replacement and taller windows. The room was heated by a fireplace in the central stack with a Georgian surround and what was probably an early 19th century grate. An entry in a partition wall to the left gives access to a store room with shelves to one side and a blocked former window the other. The door to the right leads into a back corridor.

A fourth phase, probably in the mid-19<sup>th</sup> century, involved the raising of the first floor ceiling level, thereby heightening the bedrooms, and the raising of the front elevation to increase the space in the garrets (with its ceiling level possibly added and possibly the roof changed at the same time). A new staircase was added up to Room 9, its fireplace blocked up and the doorway into Room 8 moved. A row of three windows was added to the south frontage, their irregular positioning respecting the positions of the single and paired windows on the first floor level below. All the front windows were also probably changed at this time and the front porch added. The frontage to the ground floor of Room 3 was also drastically altered to include a door and two narrow windows. The side entry on to Market Street was blocked-up. Existing staircases may have been replaced as well. All this work suggests improvements connected to the building’s use as a hotel.

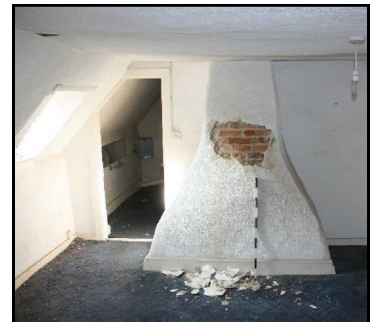
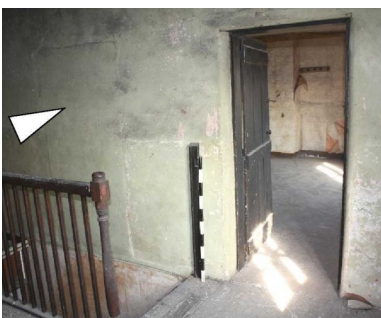
**Rooms 12, 13:**

Two unheated rooms in the north extension, with the stack standing in the middle (below). The first room was used as a bedroom and the back room as a bathroom. These are now domestic rooms for “Postman’s Cottage”. The wall between Room 12 and the main part of the building has a straight joint showing on the south side, suggestive of marking the west edge of a former window which would have been well placed to light the end of the corridor.

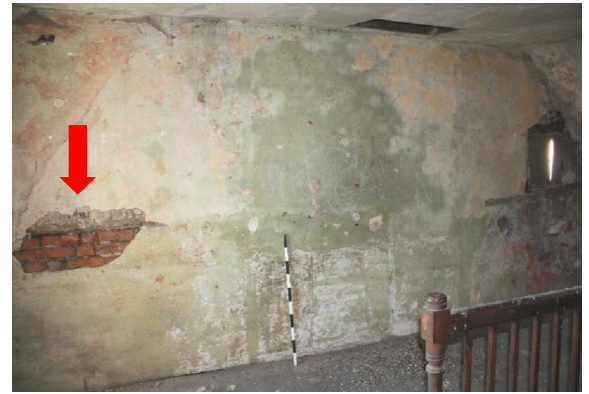
**Attic / garret Room 7:**

This small attic room is reached by a straight flight of steps off the back corridor. The flight crosses a former central doorway into Room 8, now blocked-up (arrowed, left), proving that its position is not original. The west wall of the room has a blocked up fireplace which is also not original, as the stack on the far side of the wall is a later addition serving rooms in the neighbouring property, no. 37 (above,

above, right). This wall has an added small window towards the north-west corner and a timber plate (arrowed) indicates where the circular opening shows on the outside wall, as previously mentioned. The position of this opening and its exclusivity suggests to the author that it may have been positioned to light a corner stairwell. Unlike Room 9, this end room lacks evidence for having had a centrally placed garret window.

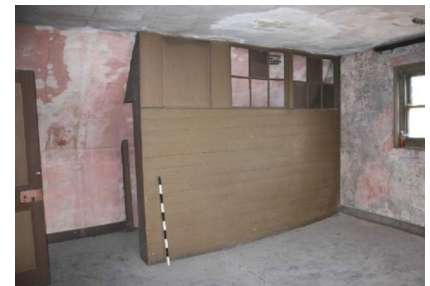
### Room 9:

The last garret room was lit by an end window. The space now includes a wooden barrier with a high window, which is best interpreted as being a private en-suite unit (although without an obvious water supply) (right).
