HISTORICAL ARCHITECTURAL SURVEY, PARRS CLOSE, 19 CHURCH STREET, BINGHAM

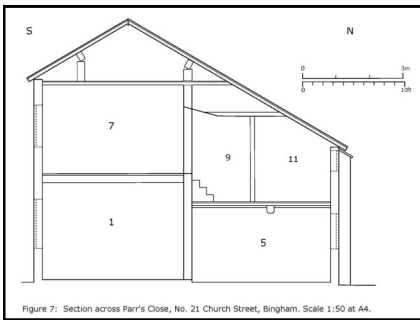
bricks can be seen along most of the two side walls, but with more variation in thickness and laid in no particular pattern; the odd lighter toned header can also be seen in places. Some thinner and earlier brickwork is evident in the north half of the building, where it occurs in almost all of the lower walling and about half of the upper walling.

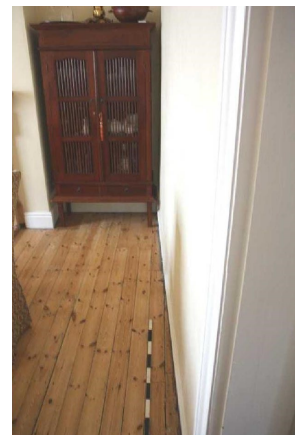
The ground floor front rooms are tall in height, are well lit by front and side windows and both rooms have fireplaces set in the end walls. There is only one staircase, a straight flight that rises from immediately behind the front door to an enclosed landing in the upper part of rear range (see below right). Before about 1990 the main

staircase led from the north end of room 1 to the landing on the south side (now balustraded). Whether this was its original position or whether the current stairs are in the original position is not known. Until about 1990 a second, twister

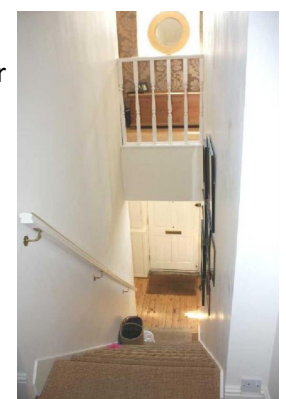
staircase, removed to enable enlargement of the bathroom, connected the SW corner of Room 5 with the upper floor. ("X" on the plan above). It had old plank doors top and bottom.

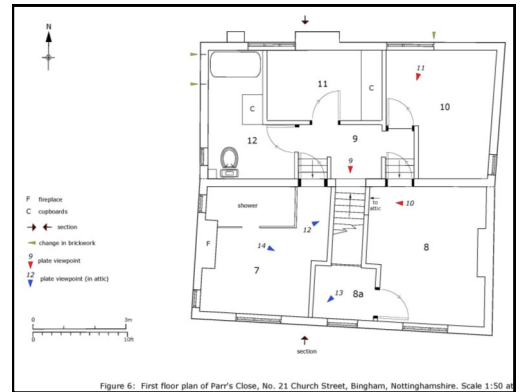
The upper floor's plan (right) reflects that of the lower level, except that the north range's pattern appears to accommodate an enclosed landing hall which allows independent access to four bedrooms and a bathroom. Including the landing, these rooms are numbered 7-12 on Figure 6, right. Short flights of steps on the landing are needed as the front bedrooms are at a significantly higher level to the north rooms.

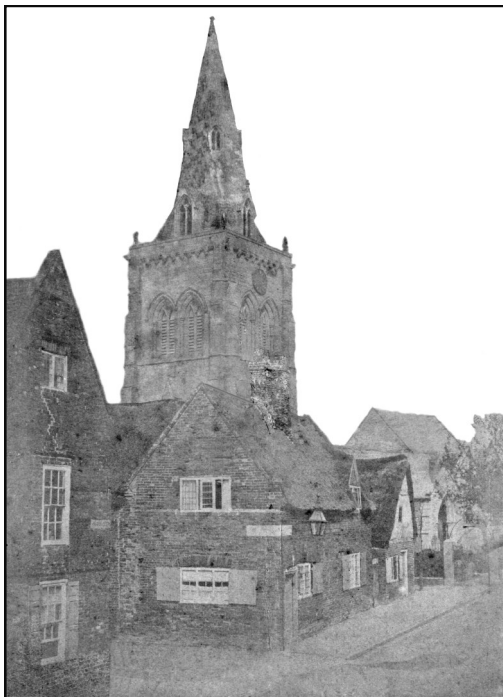
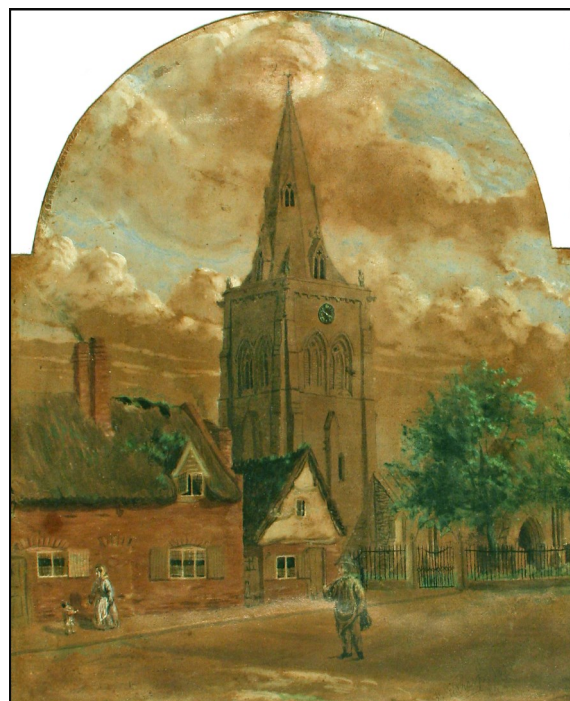
A painting from 1855 and a photograph from about the same time show the south range as a one and a half storey thatched cottage with and large windows in the west wall. Thus it is clear that the present chequerboard northern section of the house is a rebuild not a new build.
